COMANDO DA AERONÁUTICA
CENTRO DE INVESTIGAÇÃO E PREVENÇÃO DE
ACIDENTES AERONÁUTICOS

FINAL REPORT
A - 149/CENIPA/2015

OCCURRENCE:	ACCIDENT
AIRCRAFT:	PT-WQH
MODEL:	650
DATE:	10NOV2015

This is the Final Report of the 10NOV2015 accident with the 650, Citation VII aircraft, registration PT-WQH. The accident was classified as “[SCF-NP] System/Component Failure or Malfunction Non-Powerplant”.

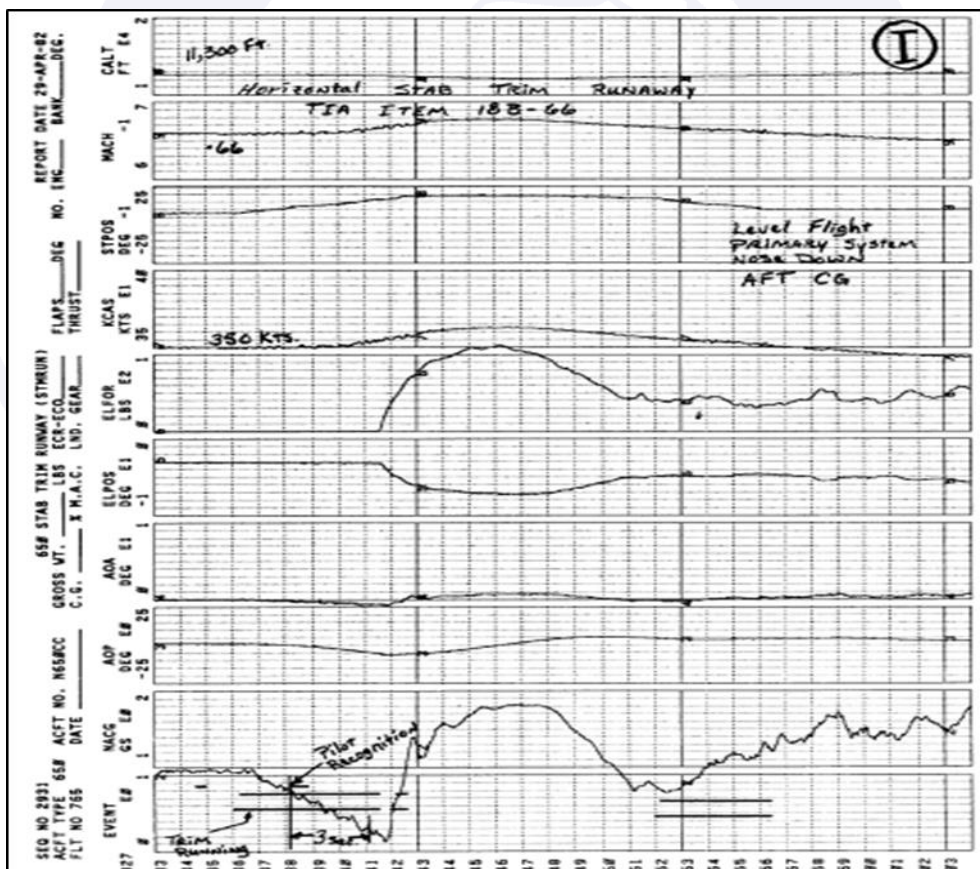
Figures 50 and 51 show the in-flight tests called the "I" Test and the "K" Test, respectively. The horizontal stabilizer trim runaway condition was tested in a straight and leveled flight situation at low altitude (approximately 11,000 feet) and the horizontal stabilizer was moved using both, the primary and the secondary pitch trim systems.

Figure 50 - In-flight test: "I" Test for horizontal stabilizer trim runaway condition. Property information of Textron Aviation®.

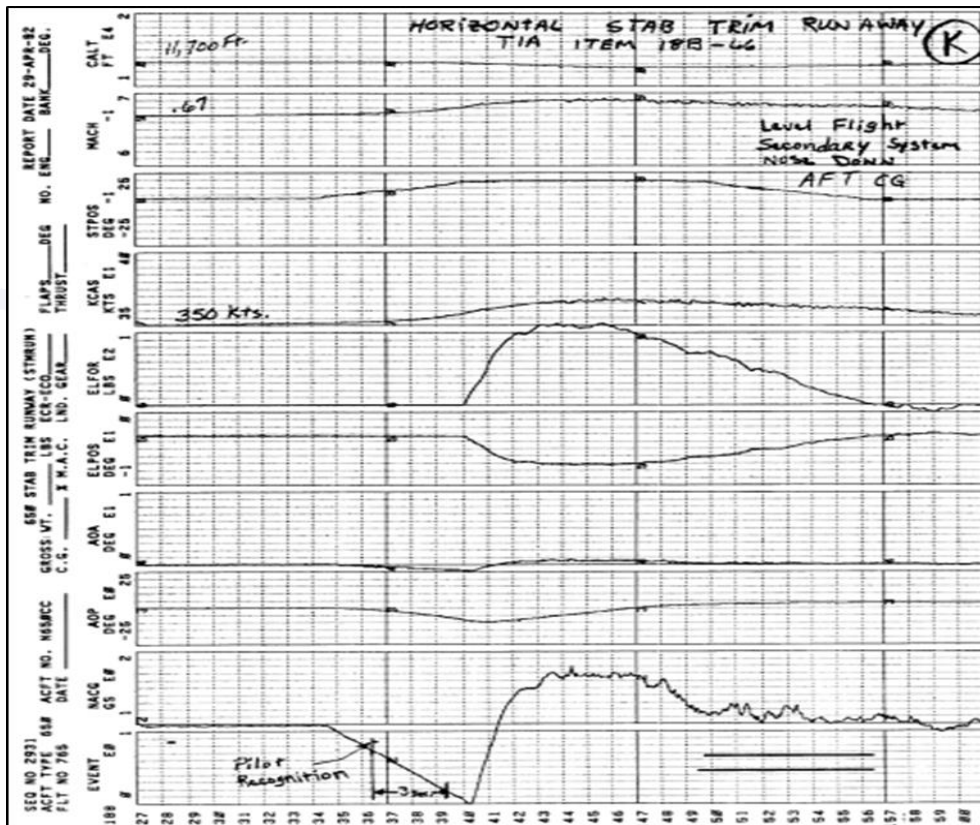
Figure 51 - In-flight test: "K" Test for horizontal stabilizer trim runaway condition. Property information of Textron Aviation®.
