COMANDO DA AERONÁUTICA
CENTRO DE INVESTIGAÇÃO E PREVENÇÃO DE
ACIDENTES AERONÁUTICOS

FINAL REPORT
IG - 190/CENIPA/2018

OCCURRENCE:	SERIOUS INCIDENT
AIRCRAFT:	PT-MUG
MODEL:	777-32WER
DATE:	20DEC2018

This is the Final Report of the 20DEC2018 serious incident with the 777-32WER aircraft model, registration PT-MUG. The accident was classified as “[SCF-NP] System/Component Failure or Malfunction Powerplant”.

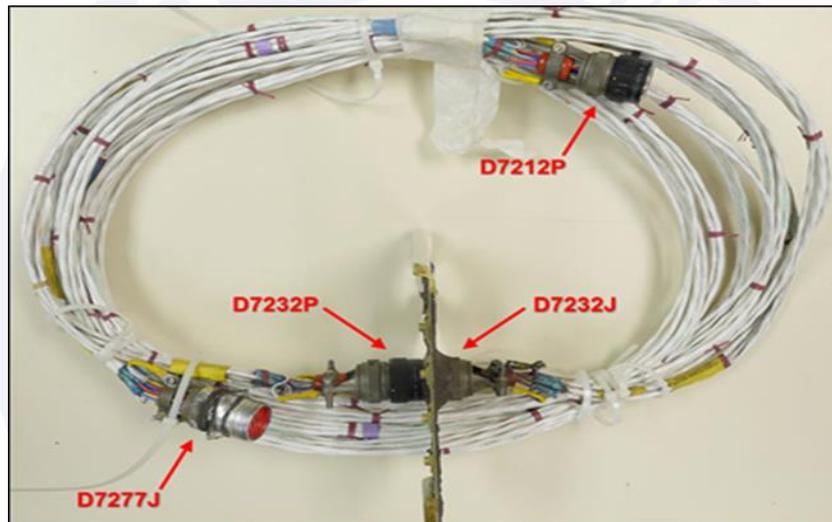
Figure 14 - Identification of the analyzed wiring parts.

The wiring removed from the aircraft was taken for analysis in the laboratory. Figure 14 shows the identification of the wiring parts.

The resistance of each thread in the wiring was measured from the adjacent connectors (D7277J and D7212P). The results are shown below and the blank spaces represent threads that did not have continuity (Figure 15).

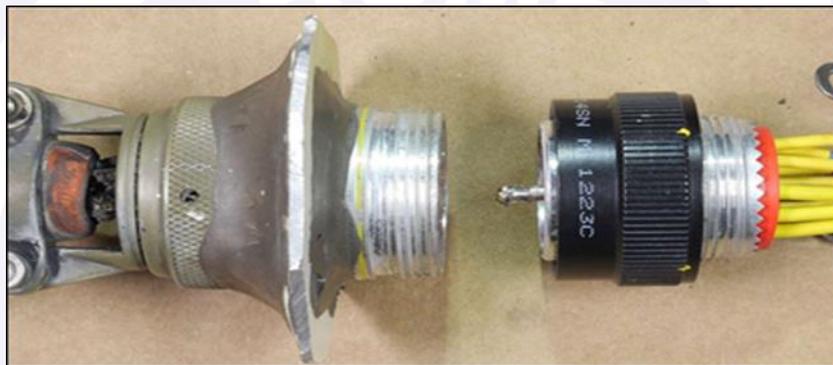
Figure 25 - Separation of the connector D7232P/J.

After non-destructive inspections on the connector, they proceeded to its disassemble, in order to check the internal conditions. The disassembly steps are shown in Figures 25 to 29, below:
