COMANDO DA AERONÁUTICA
CENTRO DE INVESTIGAÇÃO E PREVENÇÃO DE
ACIDENTES AERONÁUTICOS

FINAL REPORT
A - 121/CENIPA/2021

OCCURRENCE:	ACCIDENT
AIRCRAFT:	PT-ONJ
MODEL:	C90A
DATE:	05NOV2021

During the approach phase, under Visual Meteorological Conditions (VMC), the aircraft collided against a lightning arrester cable of a power grid on the final approach to threshold 02 of Caratinga Aerodrome (SNCT), Ubaporanga - MG, resulting in loss of control and the impact of the aircraft against the ground.

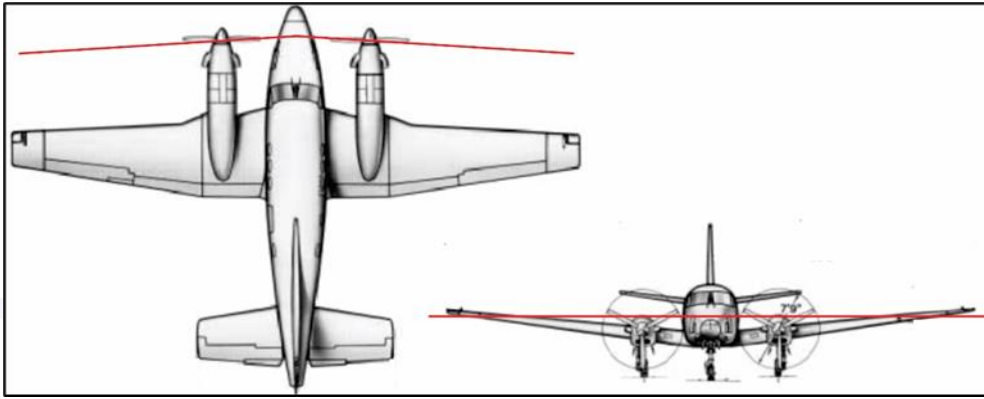
Figure 39 - Illustration of the cable's contact points on the aircraft (the red line represents the lightning arrester cable).

Considering the marks left by the cable on the spinners and the fuselage, it was verified that the aircraft hit the cable with the upper part of the nose, in a position slightly ahead of the projection of the electronic equipment compartment door. This point was located below the pilots' line of sight (Figure 39).

As illustrated in Figure 39 and based on the damage to the spinners, it is concluded that the aircraft had a bank corresponding to that of leveled wings at the moment of impact.

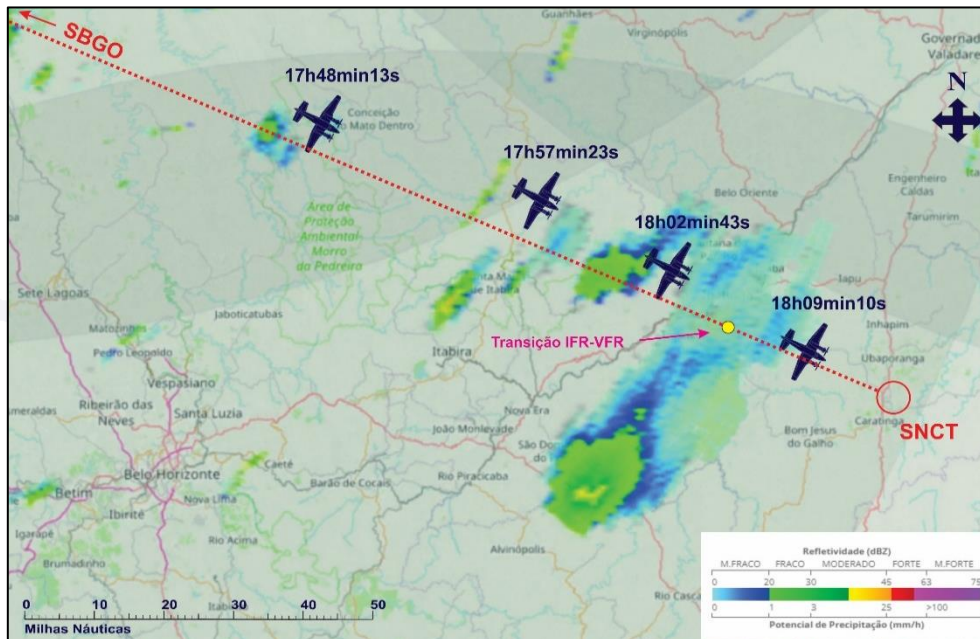
Figure 44 - Route deviation in relation to the areas with precipitation recorded at 18h07min (UTC). The dot indicates the coordinates recorded in the flight plan for the change of rules from IFR to VFR (*aircraft out of range).

According to the RADAR revisualization, synchronized with the Meteorological RADAR data of 18h07min (UTC), it was observed that the aircraft made deviations of up to 6 NM to avoid areas with low precipitation (Figure 44).

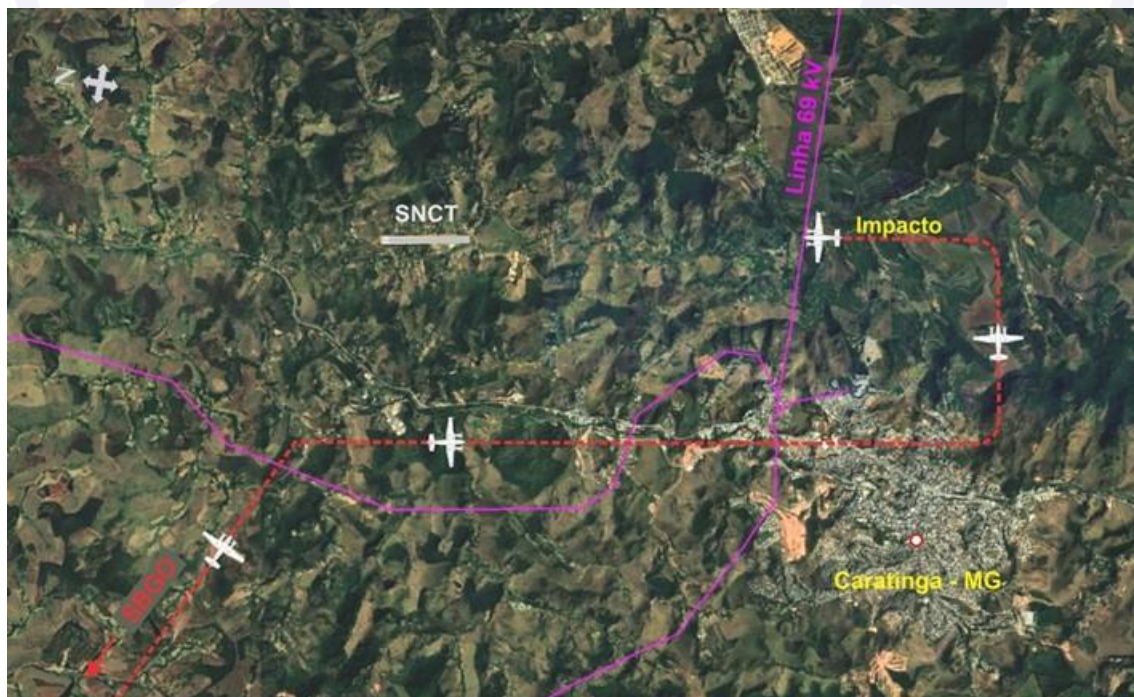
Figure 47 - Estimated trajectory until the impact (aircraft out of range).

Based on the information corresponding to the last RADAR contact; the approach sector concerning SNCT; reports from crewmembers who contacted the aircraft in flight; ground observers who saw PT-ONJ in the traffic circle; and the aircraft impact point, the Investigation Team considered that the PT-ONJ followed a trajectory as estimated in Figure 47.

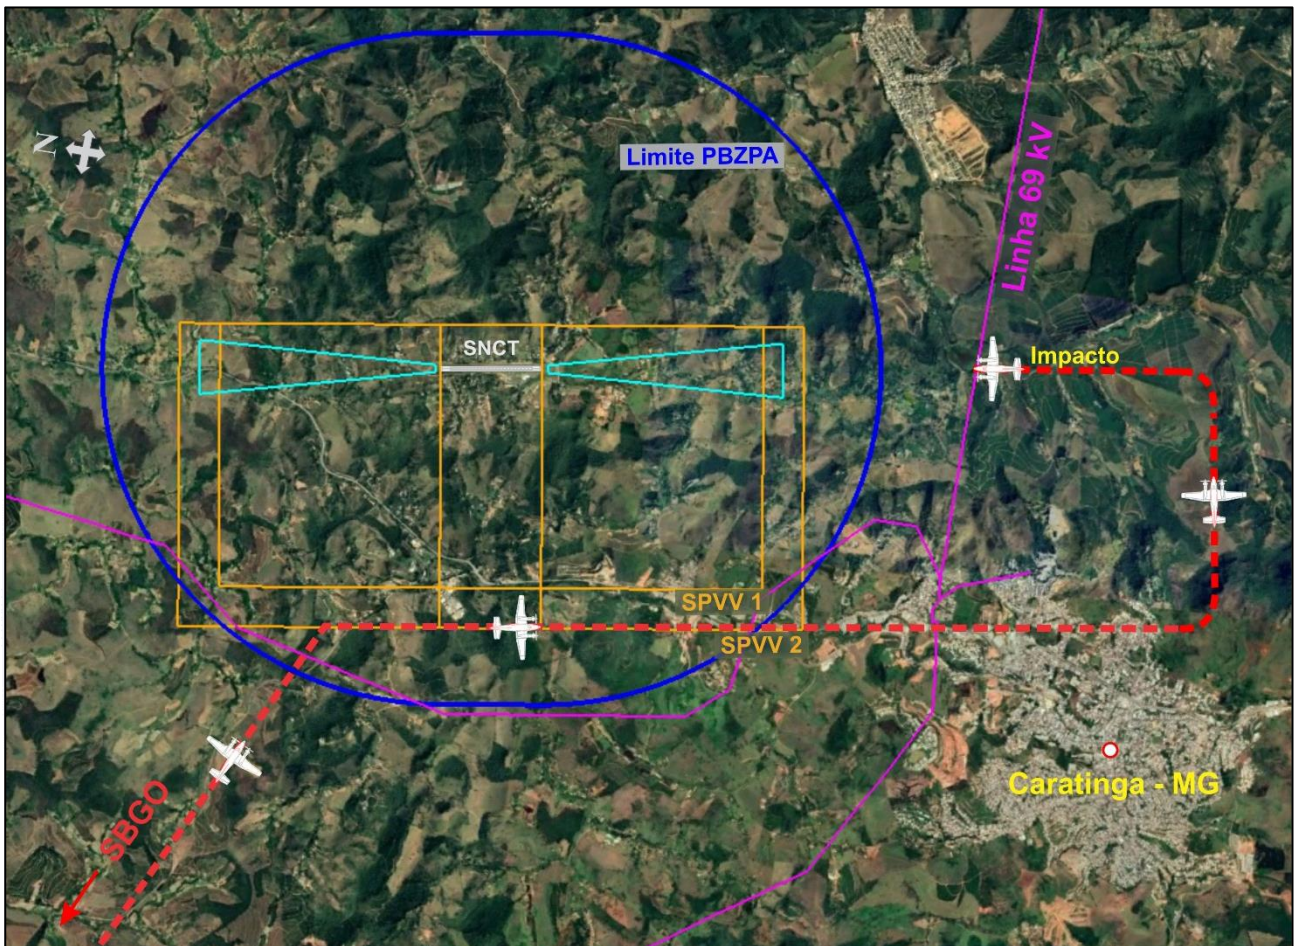
Considering the marks left by the cable on the spinner and fuselage, it was found that the aircraft hit the cable with the top of its nose and was wing-leveled at the time of impact.

Based on the aircraft configuration, banking, and the aircraft position relative to the runway axis, it is inferred that, at the time of the collision, the crew was seeking to fit into a final approach that was longer than the normal pattern for a C90A aircraft (Figure 49).

Figure 1 – Estimated Trajectory of the PT-ONJ in relation to SPVV and the point of impact against the 69 kV power grid.

The collision with the lightning arrester cable resulted in traction forces that pulled out the left engine from its attachment, still in flight, and caused the total loss of control of the aircraft.
