# COMANDO DA AERONÁUTICA <u>CENTRO DE INVESTIGAÇÃO E PREVENÇÃO DE</u> <u>ACIDENTES AERONÁUTICOS</u>

# FINAL REPORT A - 134/CENIPA/2014

OCCURRENCE: AIRCRAFT: MODEL: DATE: ACCIDENT PR-AFA CE 560XLS+ 13AUG2014

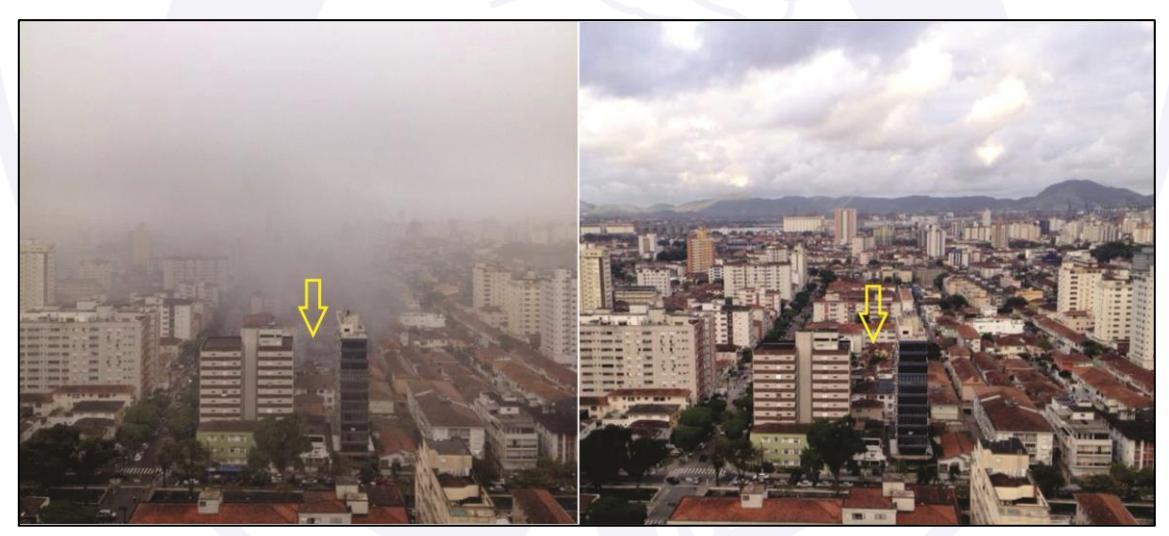
From the information above, it is possible to observe that around the time of the accident (13:03 UTC), SBST was operating under important weather restrictions, with rain and mist significantly affecting both visibility and operational ceiling from 12:00 UTC onwards. Such unfavorable weather conditions lasted more than eight hours in a row.

Figure 9 – Visual comparison of meteorological conditions over the crash site (indicated by the arrow) in two different moments: shortly after the accident (left) and on the day after (right). In the left image, it is possible to see the smoke generated by the aircraft after the crash.

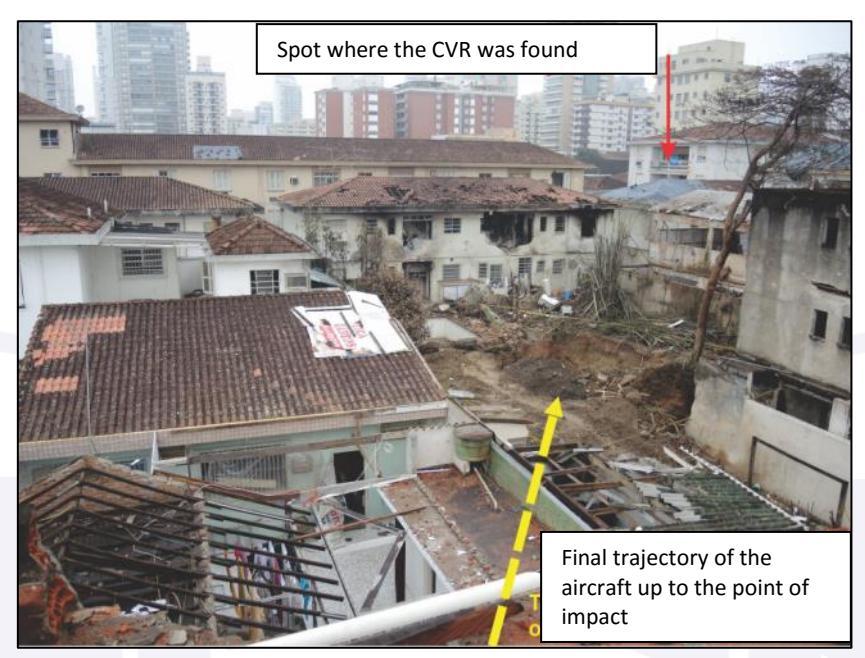
The equipment was found in the crash site (Figure 18), and sent to the CENIPA's LABDATA (Flight Data Recorder Readout and Analysis Laboratory) on the same day. The recorder had been severely damaged due to the high energy of the aircraft impact with the ground (Figure 19).

Figure 18 – General view of the crash site, with indication of the trajectory of the aircraft (yellow line) and the place where the CVR was found after the impact.

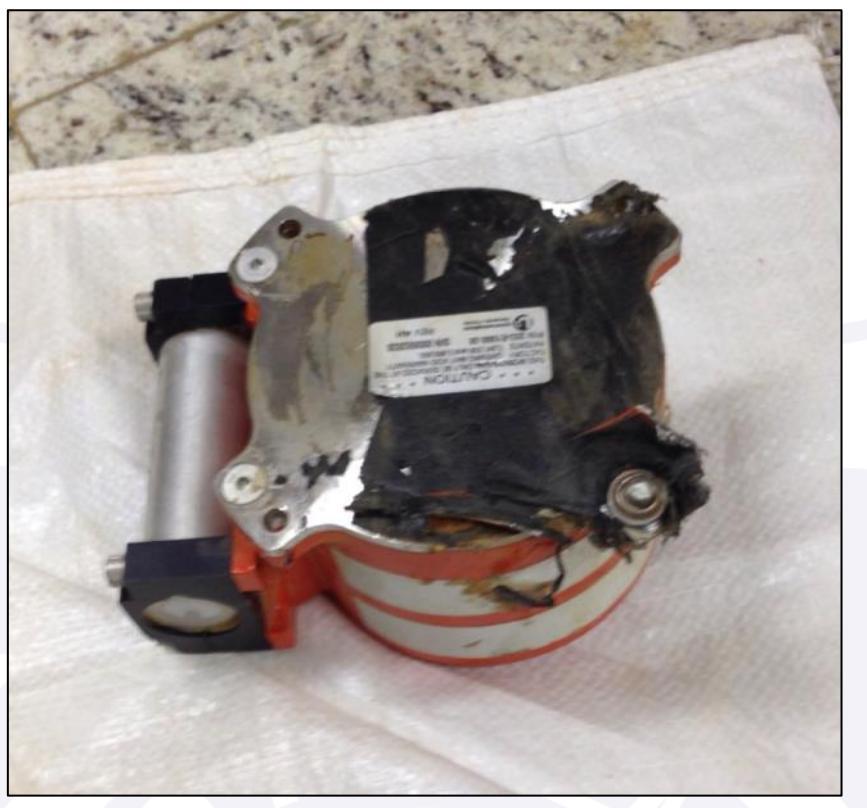
Figure 20 – FA2100 SSCVR CSMU.

Although the FA2100CVR was severely damaged after sustaining the action of a force directed to the interior of the recorder, no significant abnormalities were found in the FLASH memories, components, and associated circuitry.

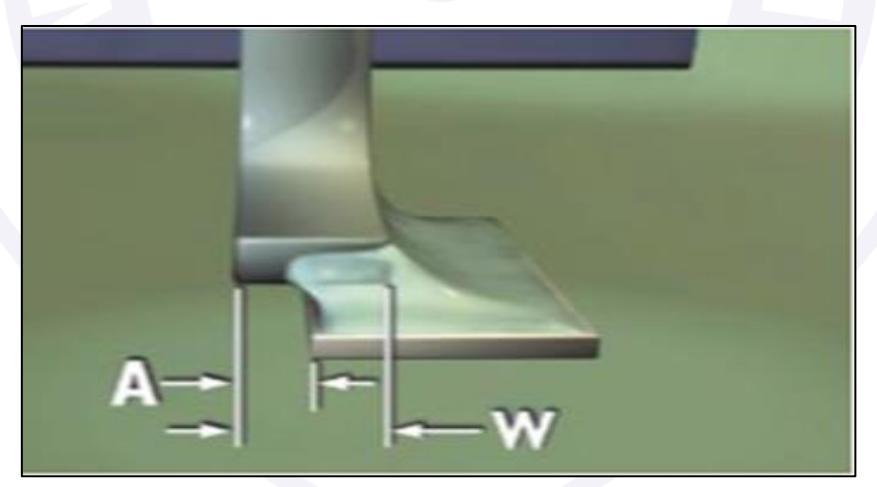
Figure 21 – Side-overhangs.

Side-overhangs: The maximum values of displacement (dimension A) detected were not higher than 50% (dimension W) or .5mm (whichever is smaller).

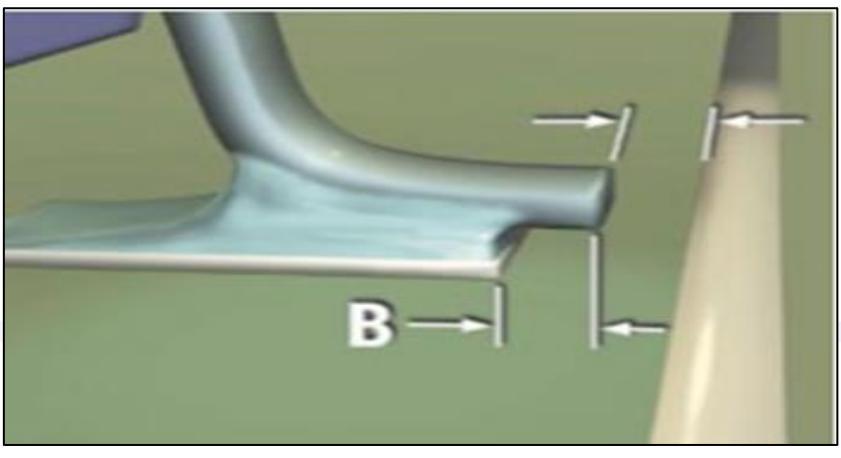
Figure 22 – Toe-overhang.

*Toe-overhang*: The maximum values detected did not violate the minimum distance of electric permissivity (dimension B).

It is observed, however, the need of a technical intervention for the replacement of the wiring that makes the interface between the FLASH memory modules and the Acquisition Processor Board (AP), due to the damage sustained in the accident (Figure 22).

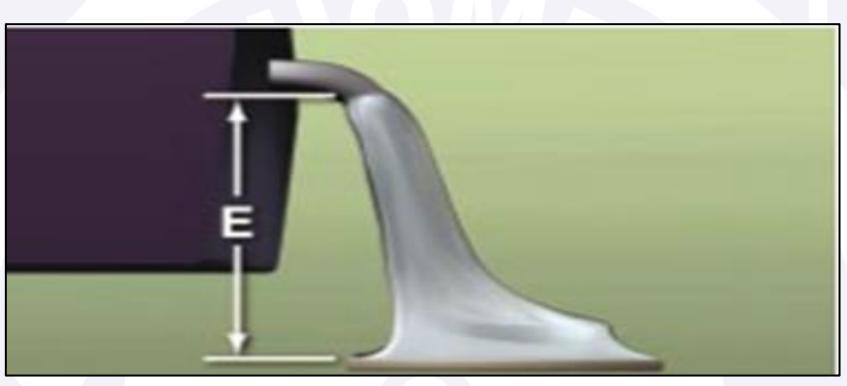
Figure 23 – Heel Fillet Height.

Heel Fillet Height: Although the solder is uniformly spread over the surface of the associated circuit track, favoring an appropriate attachment between the terminals of the FLASH memory and respective track, the examination did not find fractures nor points whose solder fillings had physical contact with the encapsulation of memory (dimension E).

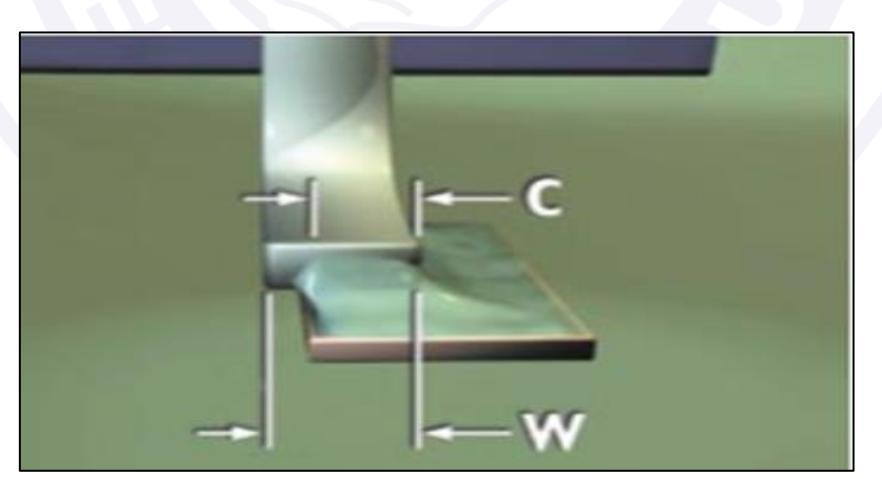
Figure 24 – Minimum End-joint width.

*End-joint width*: No terminals were detected whose maximum values of the contact surface (dimension C) were less than 75% of the area prescribed for the terminal attachment - associated circuit track (dimension W).

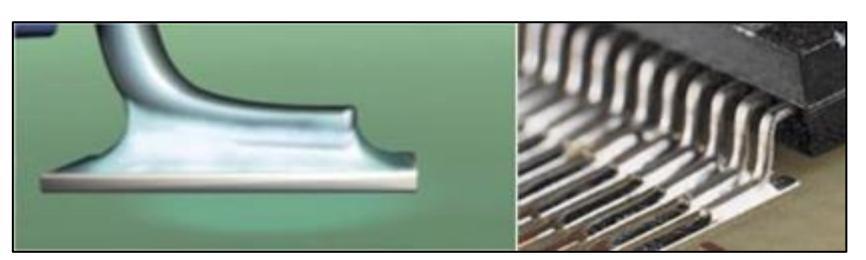
Figure 25 – Minimum Side-joint length.

*Side-joint length*: There was no detection of terminals with signs of discontinuity of solder fillings along their length.

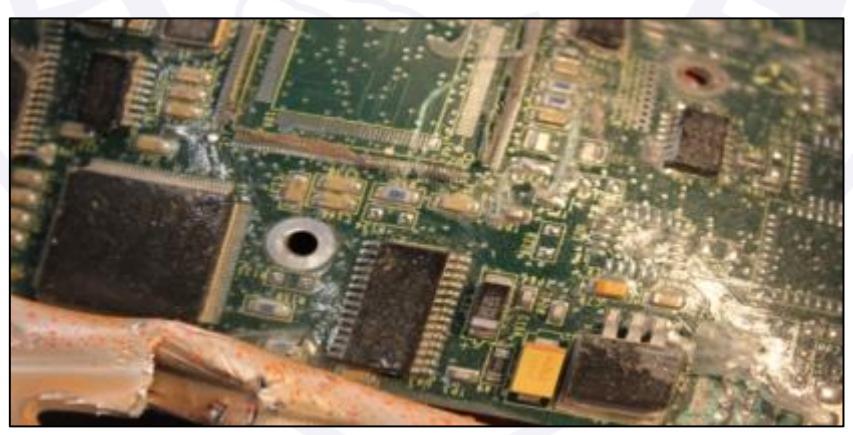
Figure 30 – Acquisition Processor Board after being removed.

The procedure began with the removal of the Acquisition Processor Board (AP) in order to get access to the NVRAM, where the CVR fault logs are stored. After a detailed exam of non-volatile memory, the decision was to withdraw the chip and then install a new AP in order to continue with the process of extracting the fault log.

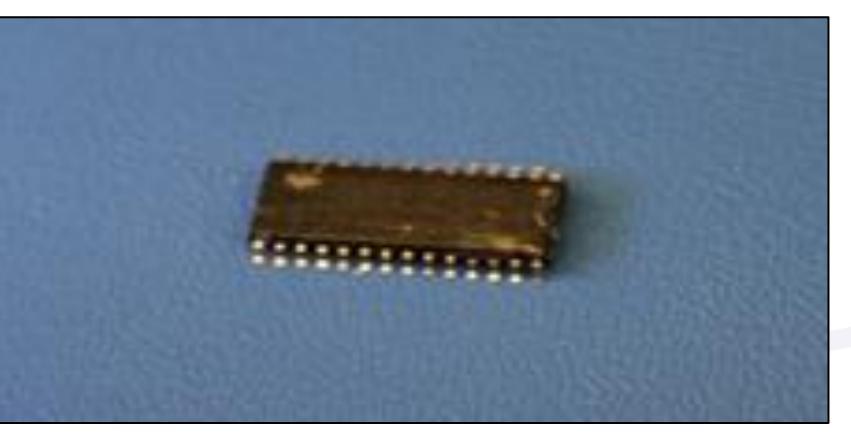
Figure 31 – NVRAM after being removed.

After the NVRAM was successfully removed, a new AP was installed for the extraction of the Fault History Log from the component.

However, they did not find any technical evidence of failure of the CVR operation.

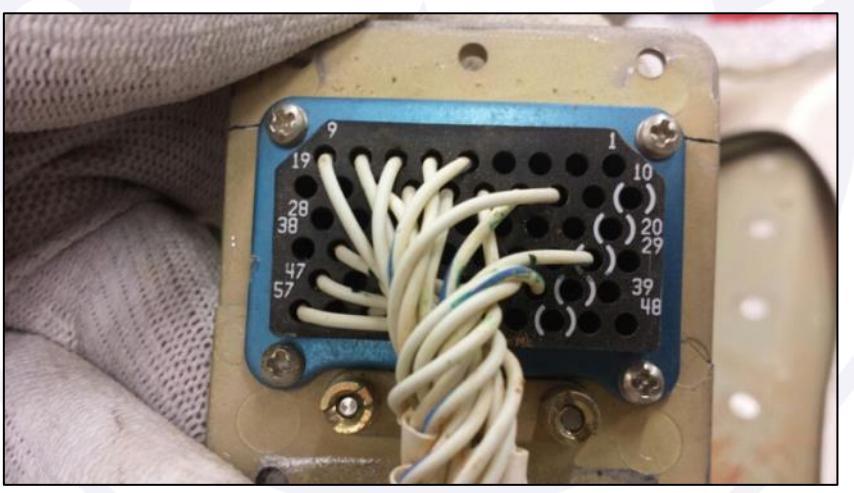
The FA2100CVR operates at a voltage of 28 DC and in its feeding circuitry it has circuit breaker, which 'jumps' in case of overcurrent, thereby disconnecting the CVR from the feeding circuitry.

Figure 34 – Rear connector of the FA2100CVR with respective wires and pins.

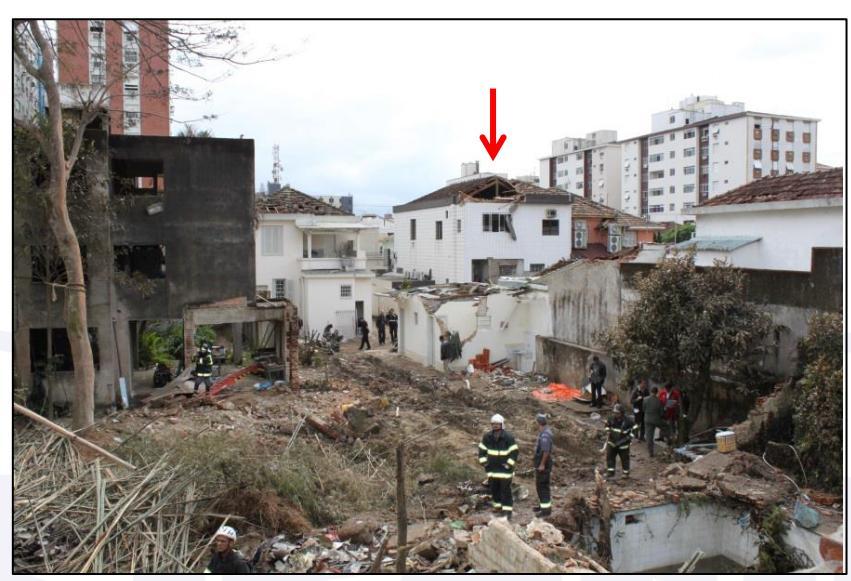
Inspection of the accident site revealed damage to the roof of a building. The upper surface of the concrete ceiling was located 25 feet 5 inches above ground level (location of the first impact).

A portion of the right main landing gear fairing was located on the top of the upper surface of the concrete ceiling (first point of impact); the part was located at 23°57.545'S, 046°19.595'W.

Figure 36 – Crash site looking to the northeast (NE), with the red arrow showing the point of first impact (on the roof).

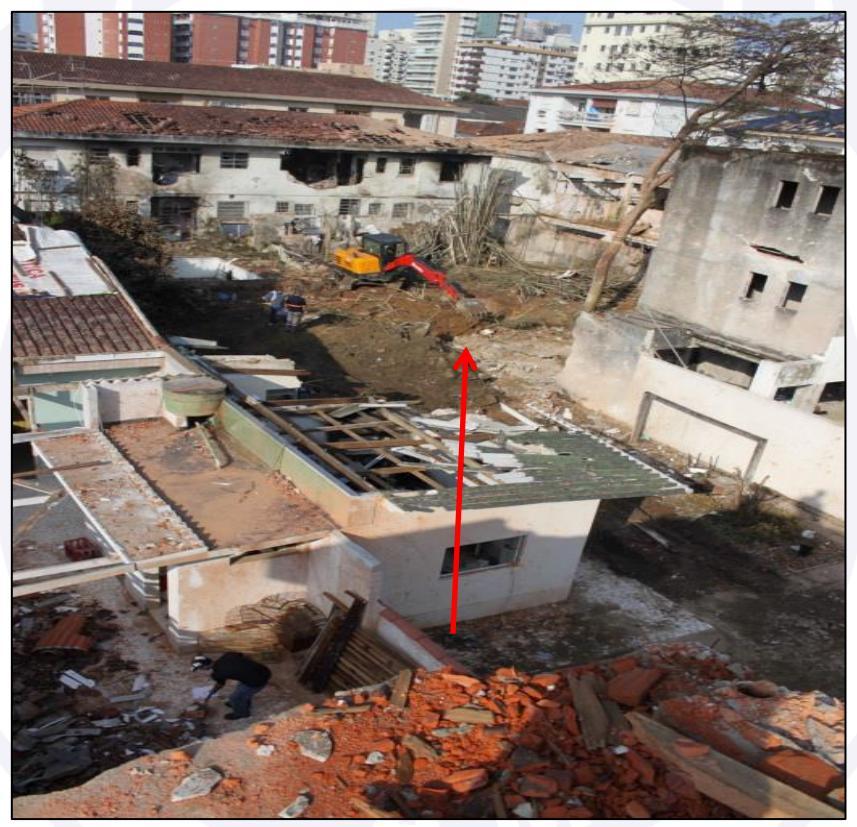
The GPS coordinates of the roof edge were 23°57.568'S, 046°19.605'W.An energy path from the roof contact point to the ground impact crater was oriented on a magnetic heading of approximately 220 degrees, and the flight path angle from the roof to the ground contact point was approximately 26 degrees. The main impact crater was located at 23°57.583'S, 046°19.615'W.

Figure 37 – Trajectory from the first point of impact on the roof to the point of collision with the ground (red arrow), looking to Southeast (SE).

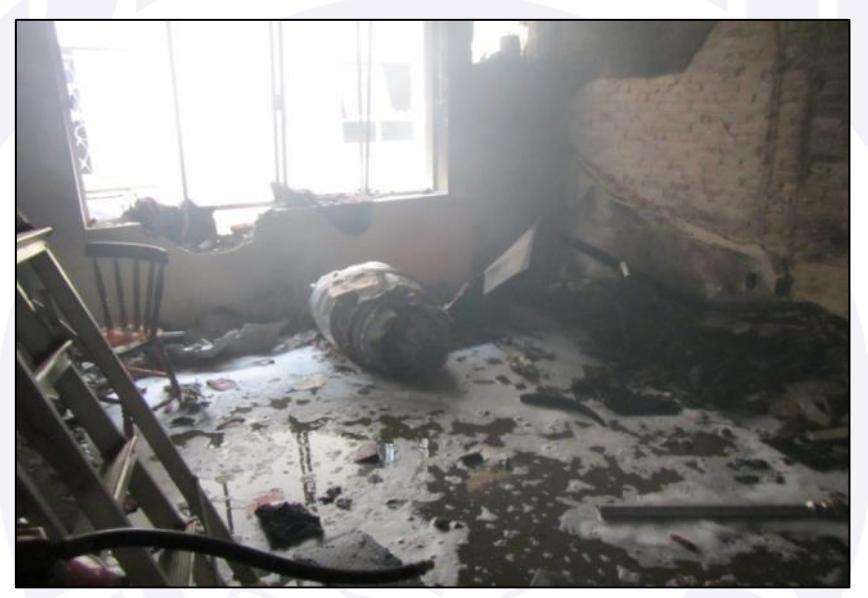
The left engine was recovered from the second floor of the building forward of the impact site and concentration of the wreckage (Figure 38). It exhibited heavy crushing of the diffuser, and its N2 shaft was protruding (Figure 39), while the other engine, found on the ground close to most of the wreckage (Figures 40 and 41), exhibited one impeller visible and had dirt adhered to it. Both engines and separated engine parts were secured for inspection by the investigators and the Pratt & Whitney representative.

Figure 39 – Spot where the left engine came to rest.

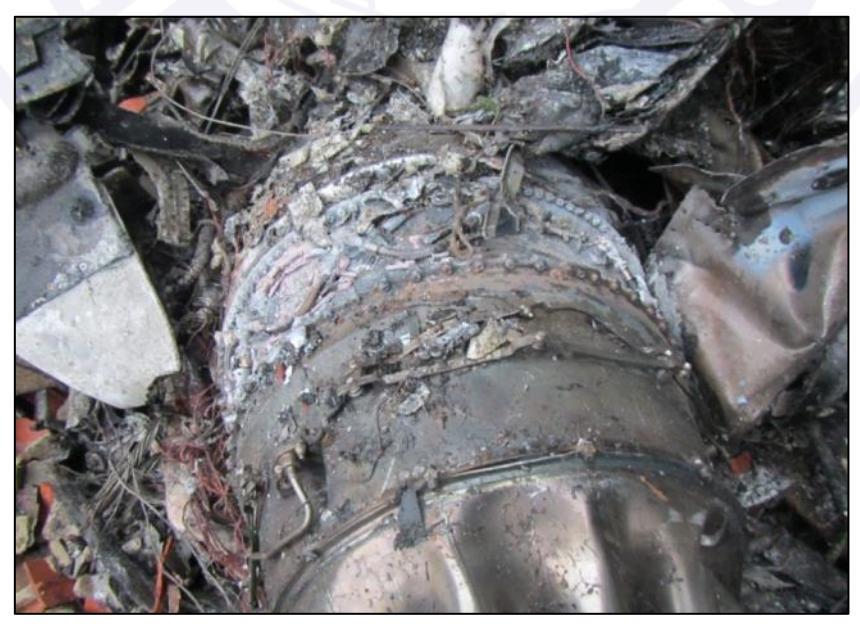
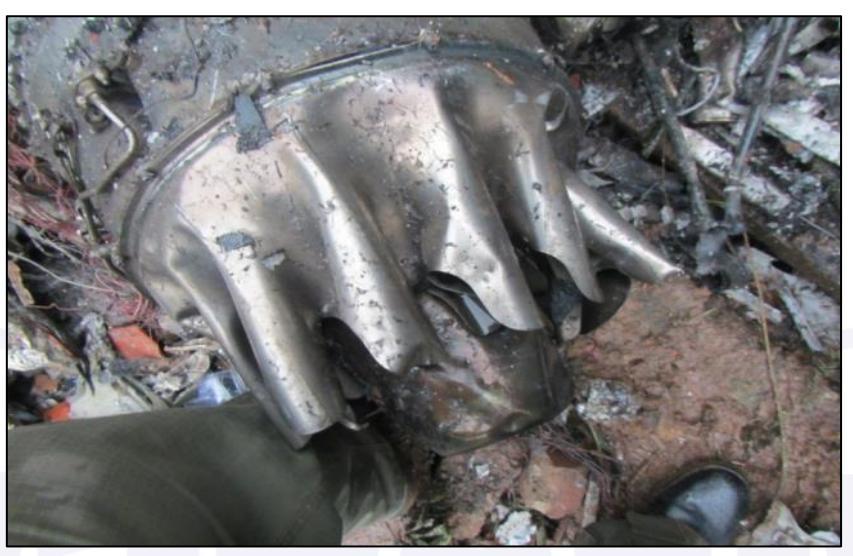
Figure 40 – View of the right engine close to most of the wreckage.

Figure 41 – View of the right engine close to most of the wreckage.

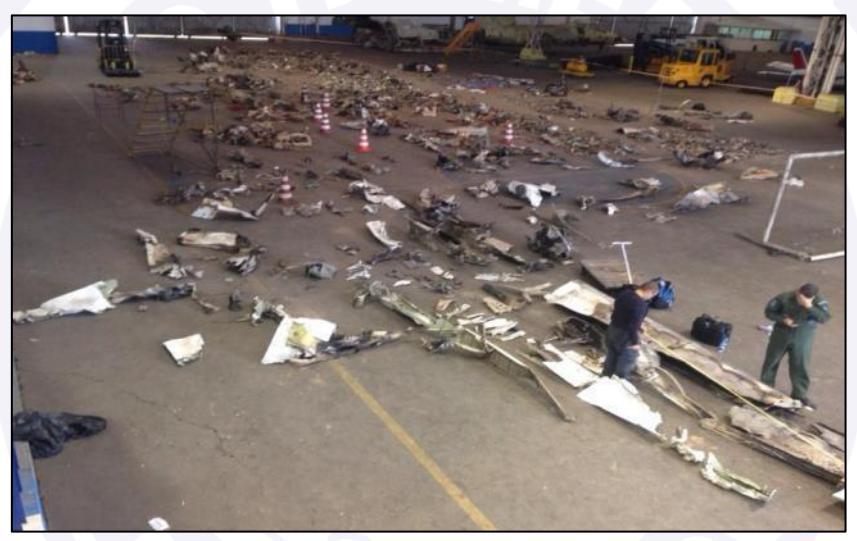
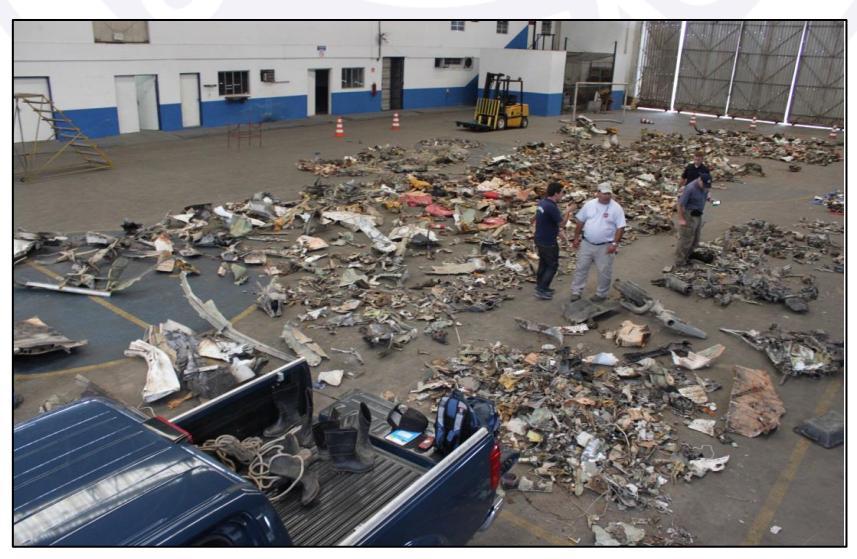
Due to the high degree of damage, the wreckage items were collected for installations of SBST with the intention of separating them according to system composition for a better understanding of the marks left and of the aircraft pre-impact configuration (Figure 42 and 43).

Figure 42 – Wreckage items arranged according do system composition in Hangar at SBST.

Figure 43 – Wreckage Deposited in Hangar at SBST.

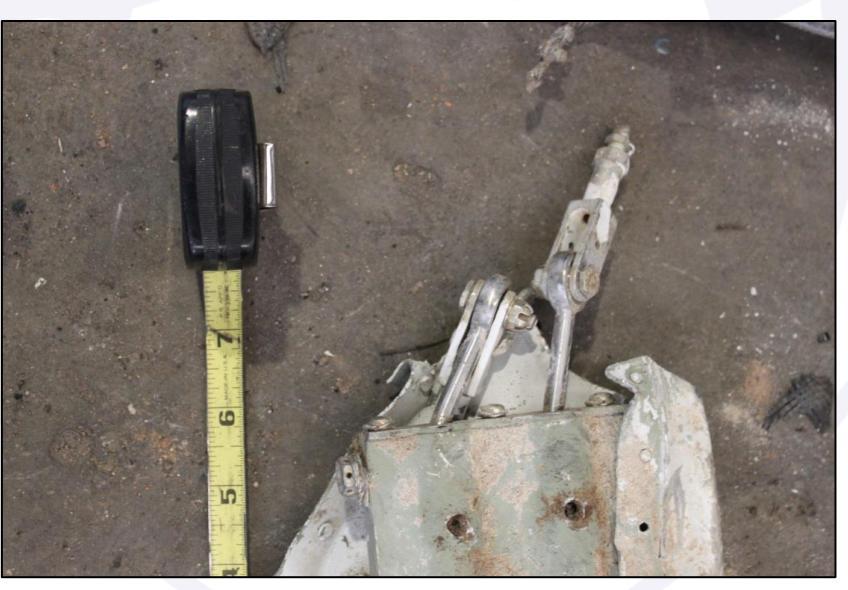
The aileron trim actuator (Figure 44) had both actuation rods bent; both measured 1.750 inches extended as measured from the housing to the center of the rod end attach bolt parallel to the rod. The speedbrake actuator was retracted (Figure 45).

All of the examined fracture surfaces exhibited features consistent with overstress failures with no evidence of fatigue.

Figure 44 – Left Aileron Trim Actuator.

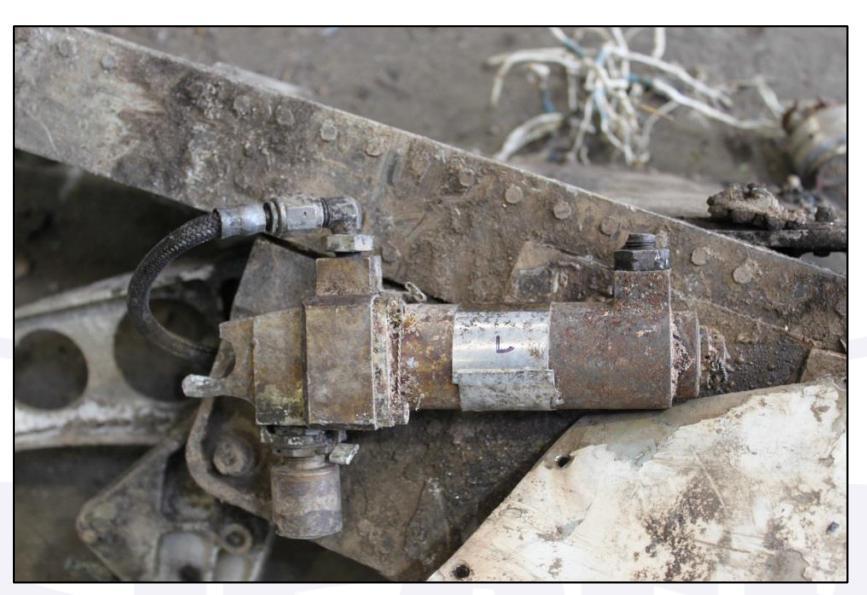
Figure 45 – Left Speedbrake Actuator in the retracted position.

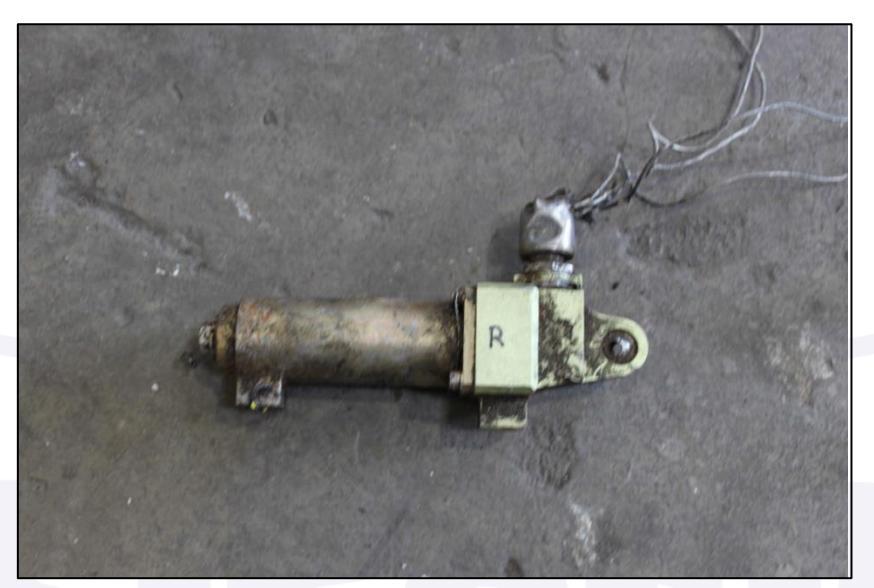
A section of lower wing skin between WS 156 and WS 171 exhibited very coarse chord-wise scratches. The speedbrake actuator was retracted (Figure 46). All of the examined fracture surfaces exhibited features consistent with overstress failures with no evidence of fatigue.

Figure 46 – Right Speedbrake Actuator in retracted position.

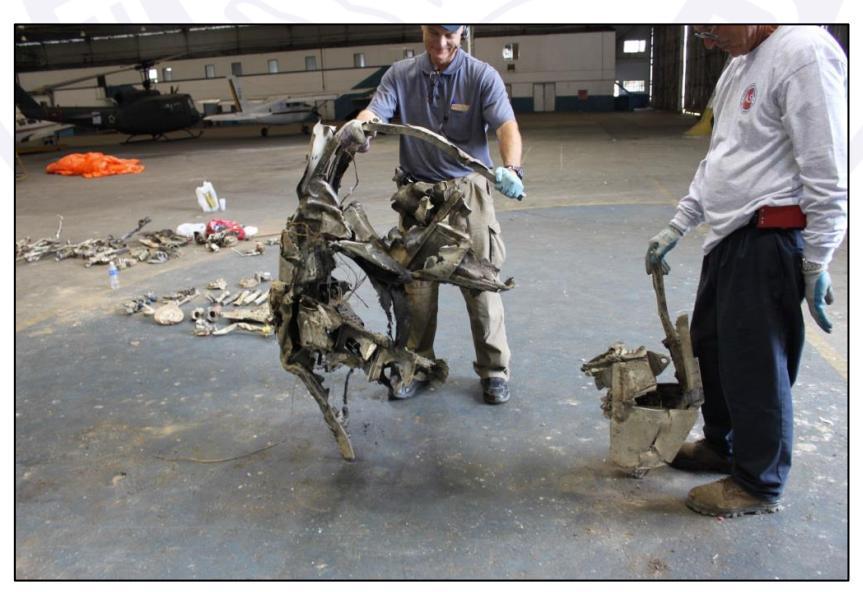
The forward and aft spars of the vertical stabilizer (Figure 47) were fragmented and separated. The canted bulkhead was fractured in several areas and was noted to be impact and fire-damaged.

Figure 47 – Forward and Aft Spars of Vertical Stabilizer with section of Horizontal Stabilizer attached.

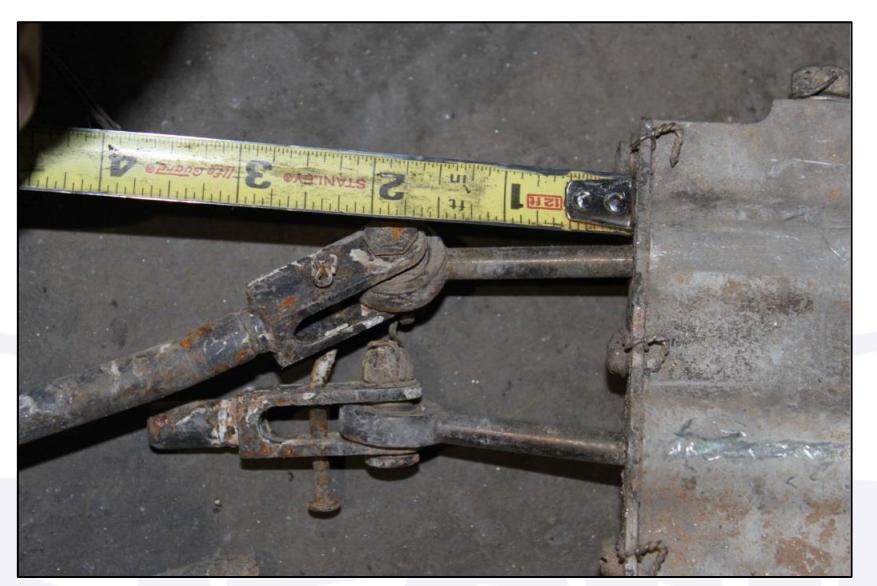
The rudder trim tab actuator (Figure 48), which was separated, was measured and found to be symmetrically extended approximately 1.7/8 inches as measured from the housing to the center of the rod end attach bolt, corresponding to be minus 1.8 degrees tab trailing edge right deflection.

Figure 48 – Rudder Trim Actuator.

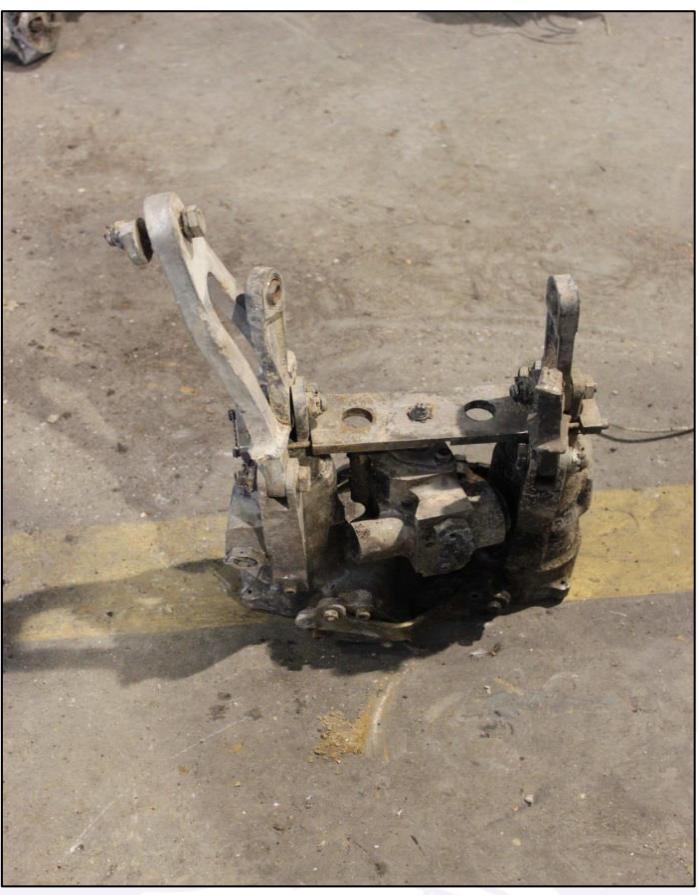
The horizontal stabilizer hydro-mechanical actuator (Figure 49) was separated, and no motor was recovered. One piston measured 1.19/32 inches extended while the other side measured 1.17/32 inches extended, which equates by engineering drawing to +1 degree horizontal stabilizer position. The actuator was heat damaged. The right side attach to the vertical spar has a bolt with cotter pin in place, while the left side attach was fractured.

Figure 49 – Horizontal Stabilizer hydro-mechanical actuator.

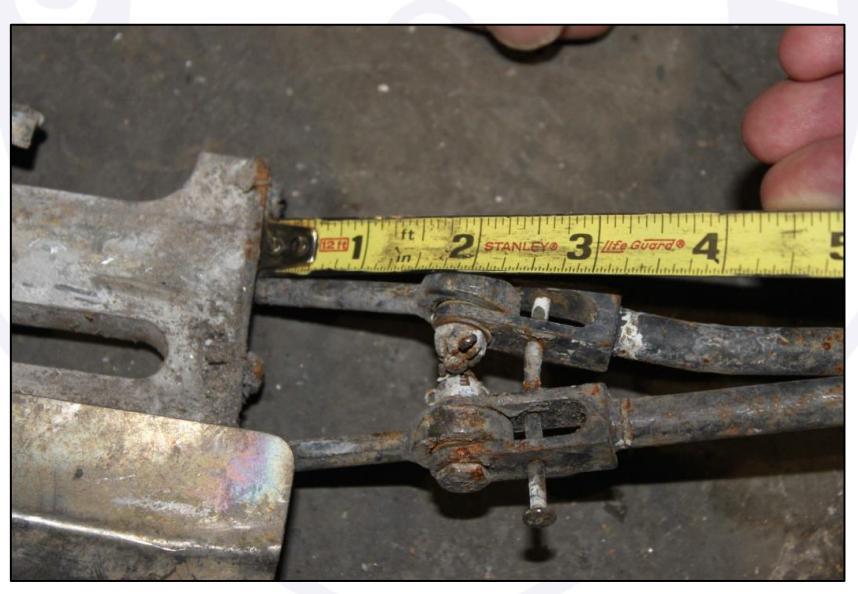
The left elevator trim tab actuator measured approximately 1.27/32 inches extended as measured from the housing to the center of the rod attach bolt. All of the examined fracture surfaces exhibited features consistent with overstress failures with no evidence of fatigue.

Figure 50 – Left Elevator Trim Tab Actuator.

The left and right actuators of the elevator trim tab were stuck on account of the impact, and their positions corresponded to zero degree and +1.8 degree, respectively.

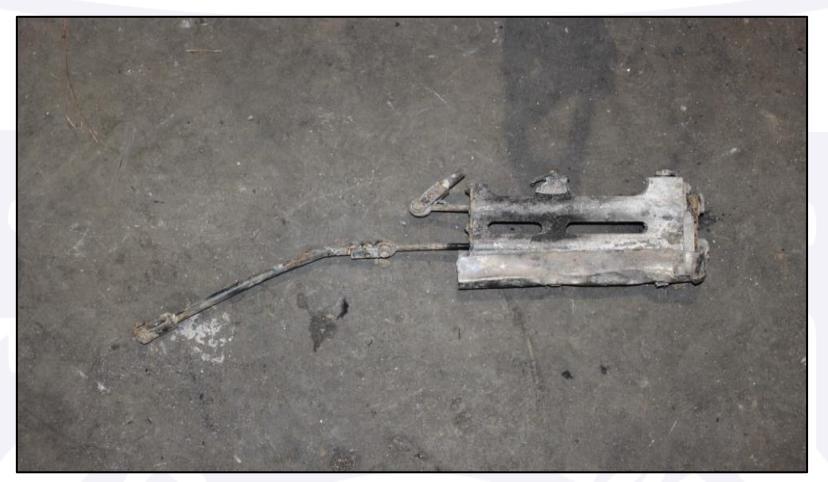
The leading edge of the right elevator was crushed aft. The elevator trim tab actuator was separated but recovered. One rod measured approximately 2.20/32 inches extended as measured from the housing to the center of the rod end attach bolt; the rod was noted to rotate freely. The other rod was bent and measured approximately 1.3/4 inches extended (did not move). The rod that was bent had a fractured rod end, but the opposite rod was full span.

Figure 51 – Right Elevator Trim Tab Actuator.

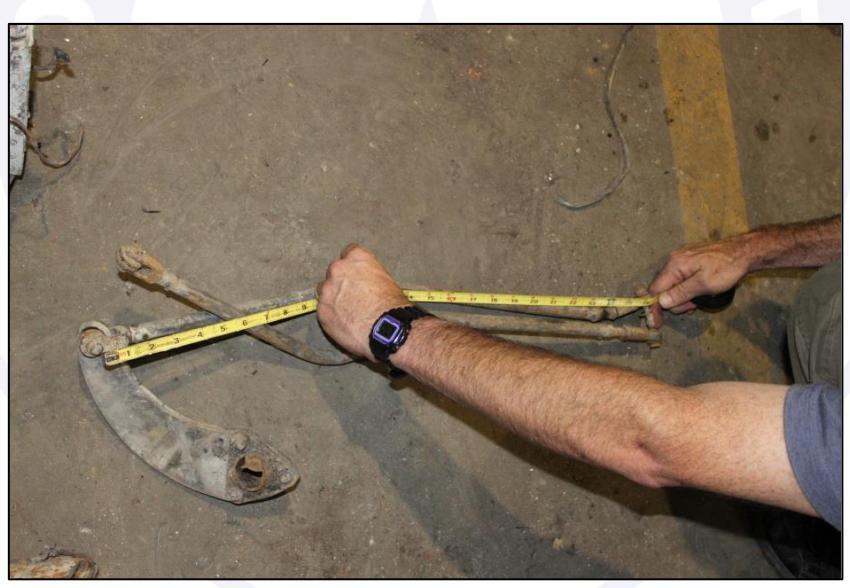
Inspection of elevator horn revealed a push/pull rod remained connected at the forward end, but the horn (Figure 52) was separated from the elevator torque tube. One rod remained connected to the elevator horn, but the other rod was separated; the bolt and bearing were in-place.

Figure 52 – Elevator Horn.

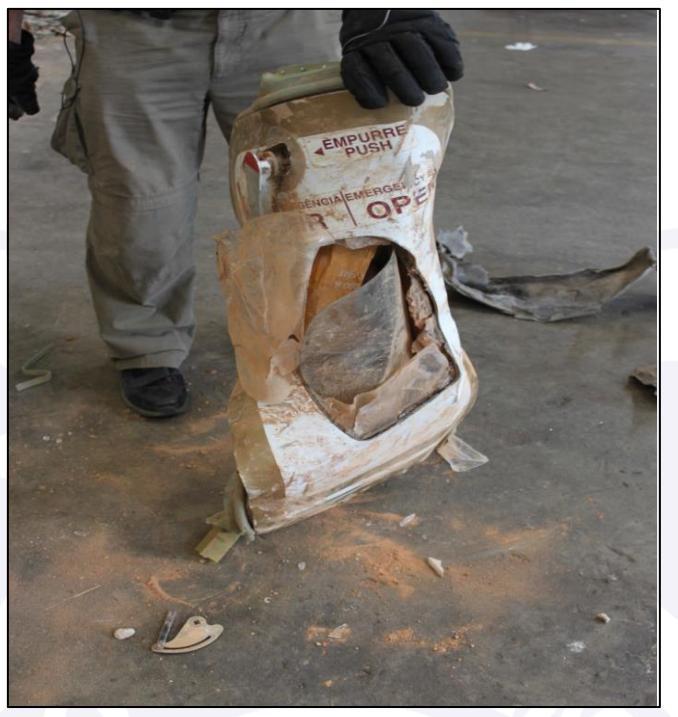
The emergency exit door (Figure 53) was heavily crushed forward to aft, and the upper 2/3's was crushed towards the interior. The door handle linkage was fractured, and

no fire damage was noted. The door had dirt adhering to it, and the interior portion of the latch mechanism was broken.

Figure 53 – Emergency Exit Door.

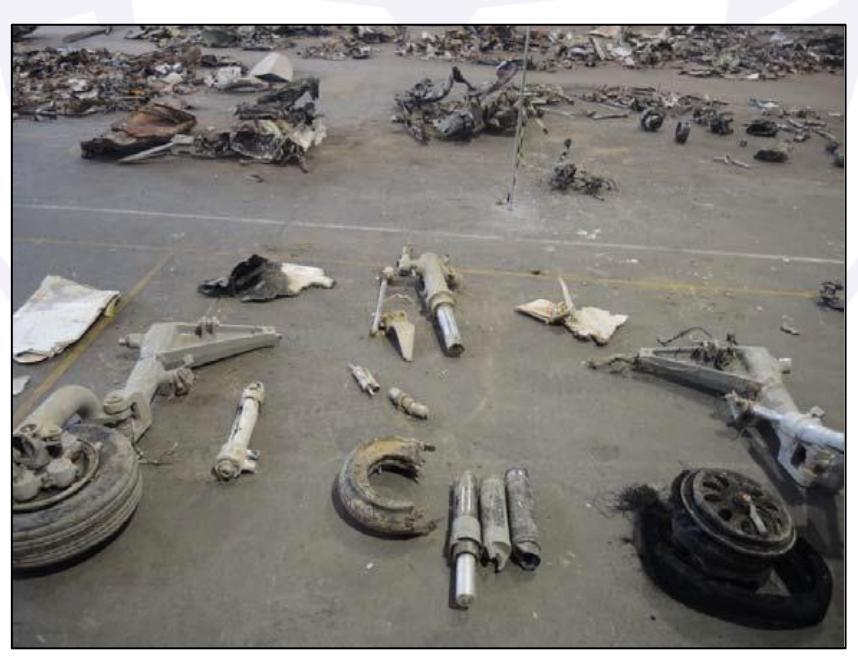
All landing gears were separated but recovered. Inspection of the actuators revealed one of the main landing gear actuators was retracted. The other main landing gear actuator and nose landing gear actuators were damaged during the impact and the pistons were pulled from their respective housings. No pre-impact anomaly was observed to the recovered components.

Figure 54 – Landing Gear Components.

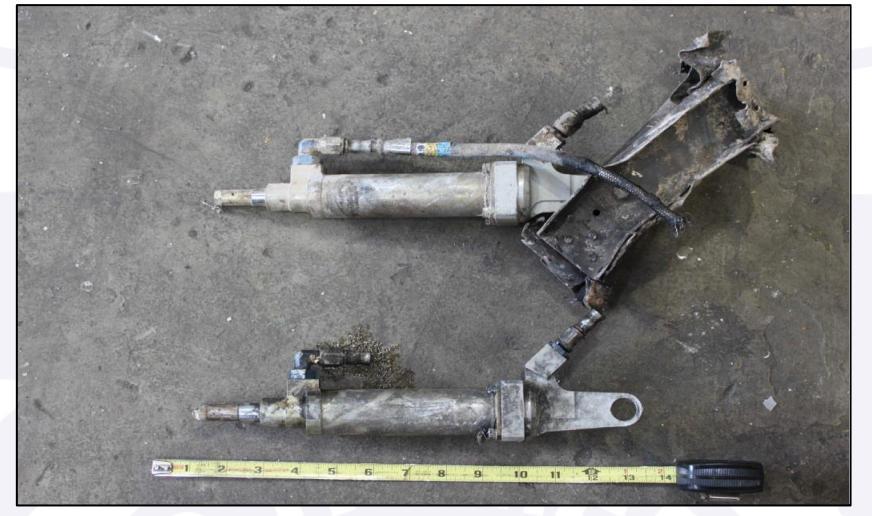
Both flap actuators (Figure 55) were separated; therefore, no positional determination could be made.

Figure 55 – Flap Actuators.

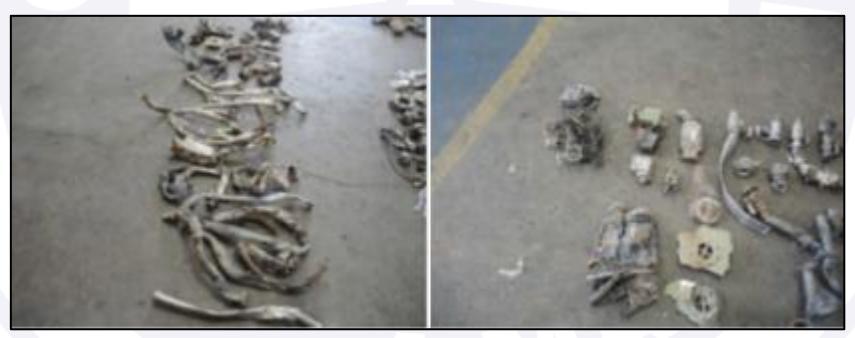
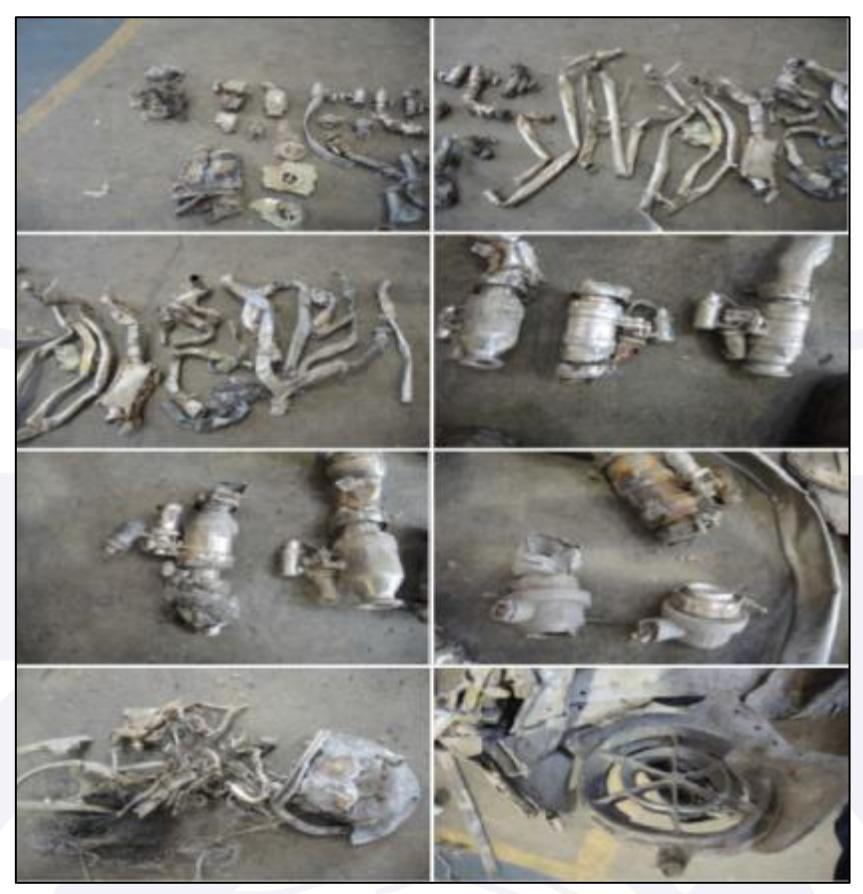
The condition of the recovered pneumatic system items and their method of operation resulted in limited investigative value. No pre-impact anomalies were noted to the recovered components.

Figure 56 – Bleed Air, Pneumatic, and Pressurization System Components.

Figure 57 – Bleed Air, Pneumatics, and Pressurization System Components.

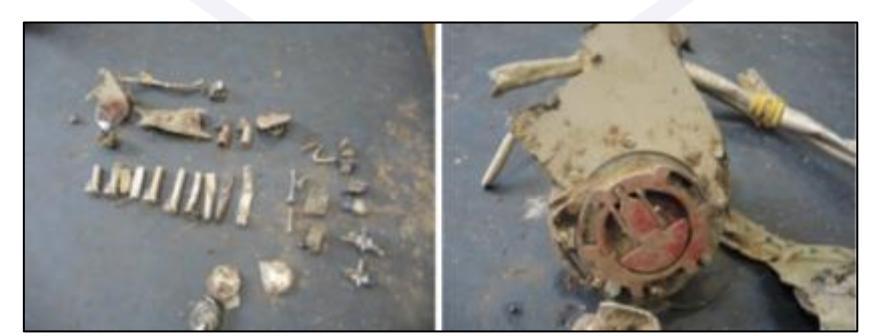
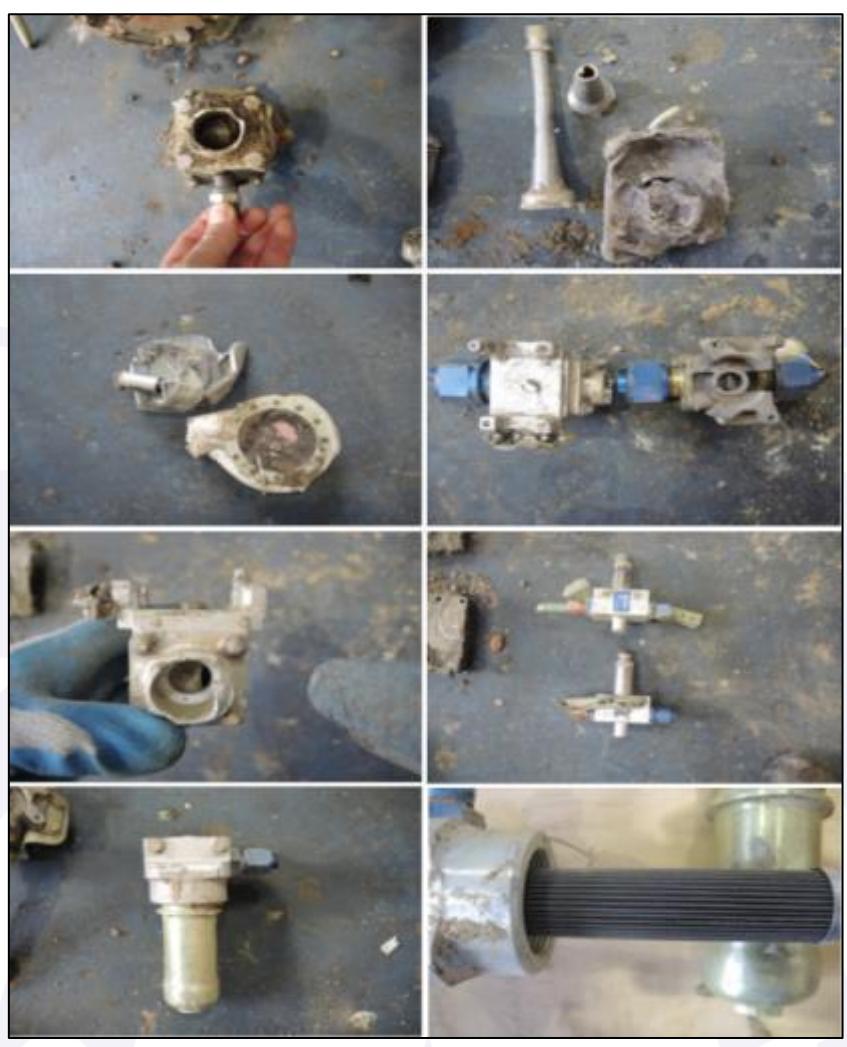
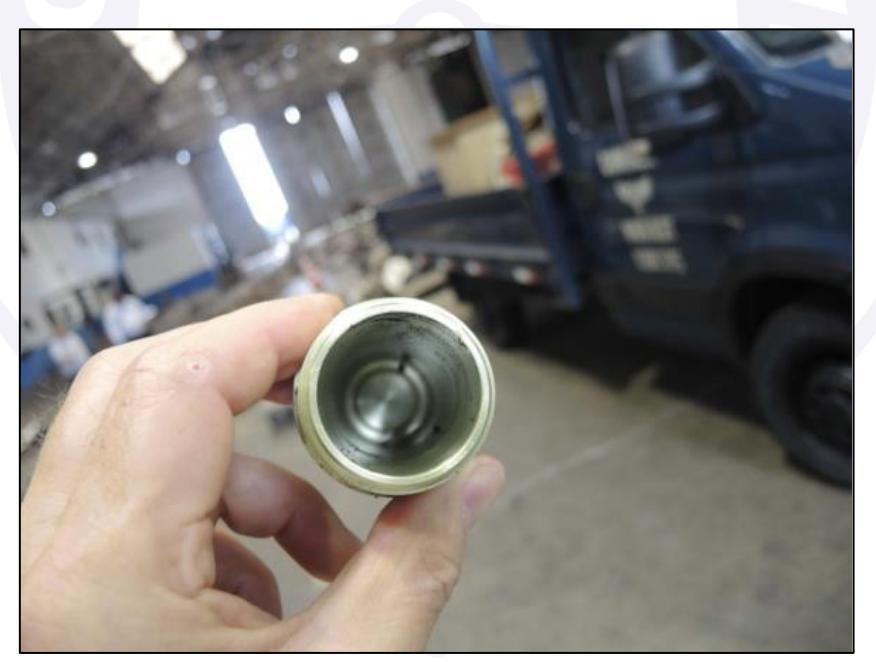
The single point refueling port and one of two overflow prevention valves were recovered and exhibited impact damage. No pre-impact anomalies were noted to the recovered components of the fuel system.

Figure 58 – Fuel System Components.

Figure 59 – Fuel System Components.

Figure 60 – Fuel System Components.

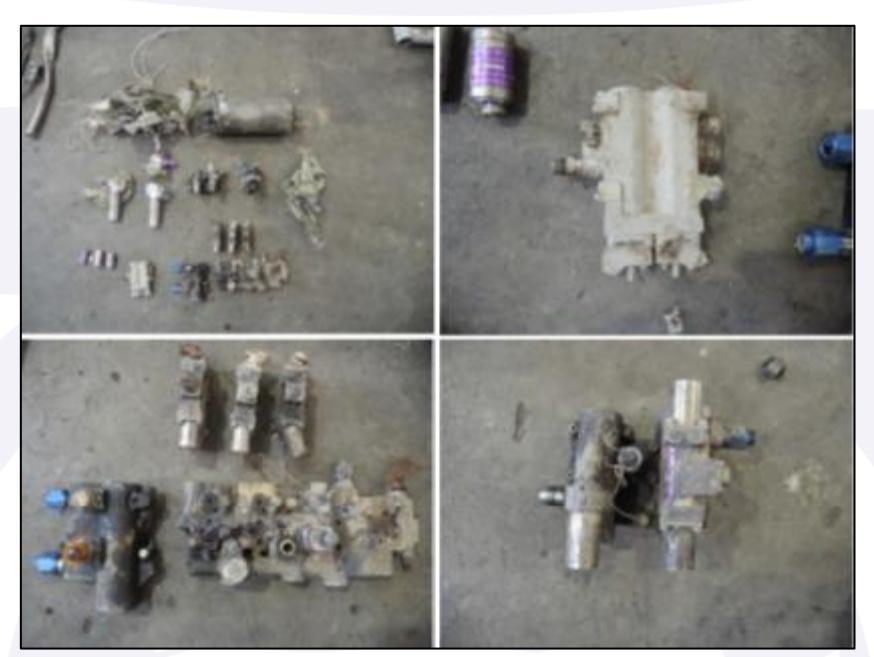
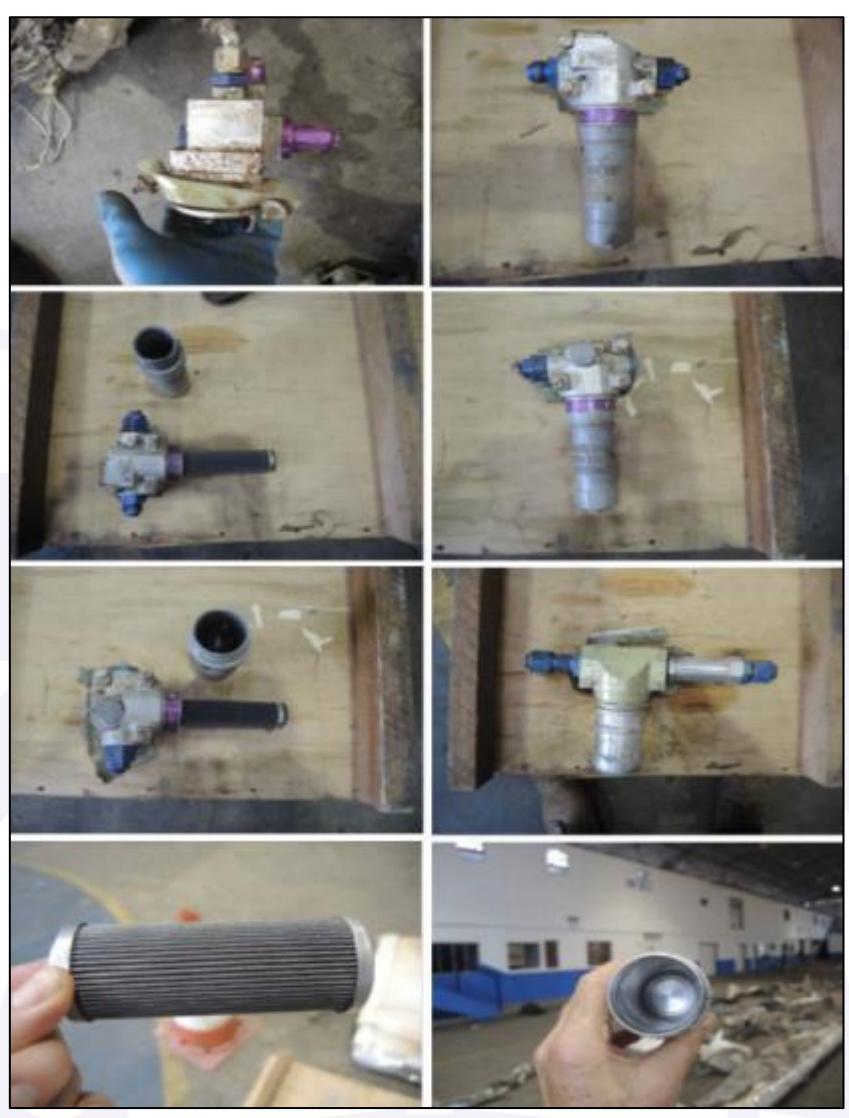
No pre-impact anomaly was noted to the recovered hydraulic system components.

Figure 61 – Hydraulic System Components.

Figure 62 – Hydraulic System Components.

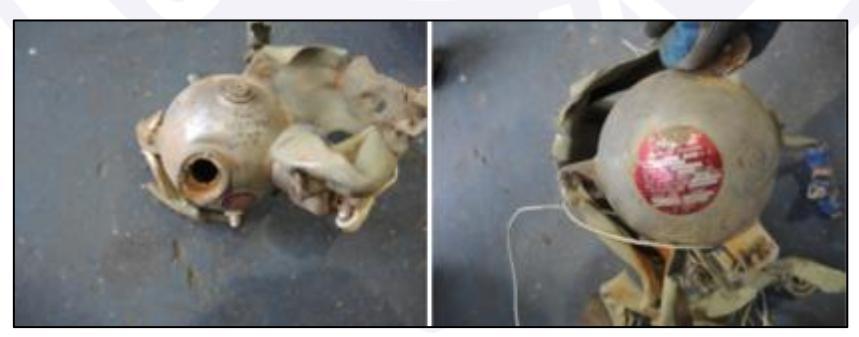
One fire bottle was impact damaged and discharged. The second bottle was damaged but retained its charge.

No pre-impact anomalies were noted to the fire control system. The fire detect system was too damaged to evaluate.

Figure 63 – Aspect of the fire extinguishing bottles.

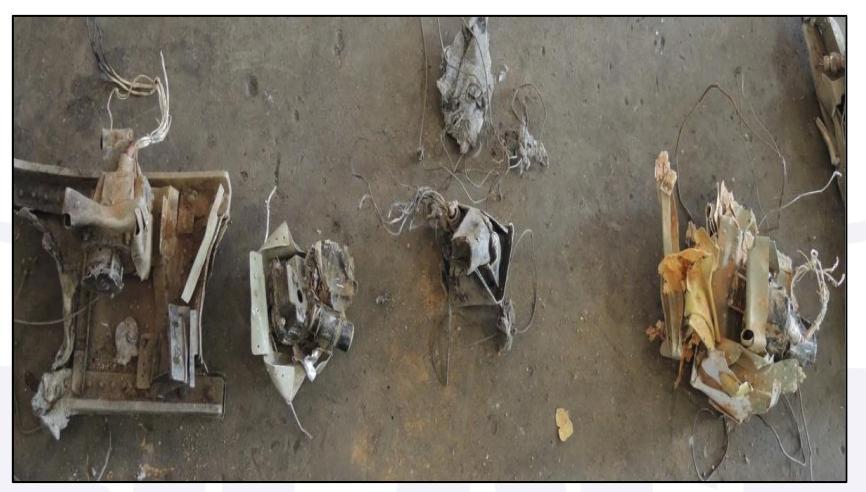
The autopilot system was fragmented and displayed thermal damage. All autopilot servos were recovered and exhibited impact and fire damage. In all cases the control cables were separated in tension overload, but remained secured to the servo capstans.

No pre-impact anomalies were noted to the recovered autopilot servos and control cable system components.

Figure 64 – Components of the autopilot system.
