# COMANDO DA AERONÁUTICA <u>CENTRO DE INVESTIGAÇÃO E PREVENÇÃO DE</u> <u>ACIDENTES AERONÁUTICOS</u>

# FINAL REPORT A - 134/CENIPA/2014

OCCURRENCE: AIRCRAFT: MODEL: DATE: ACCIDENT PR-AFA CE 560XLS+ 13AUG2014

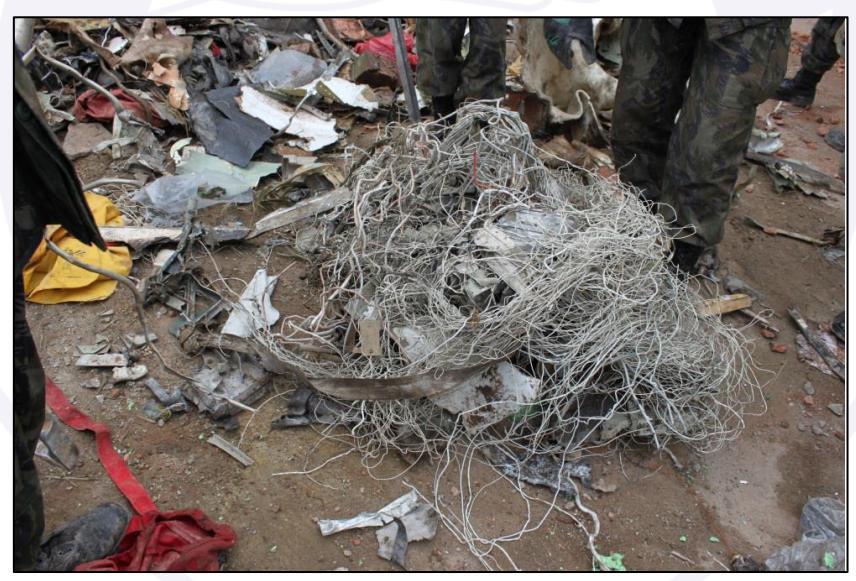
The electrical system was fragmented and extensively damaged which precluded a complete evaluation. All three starter/generators and two alternators were recovered and exhibited impact and fire damage.

One bank of unidentified current limiters was recovered; all displayed intact fuses. One bank of circuit breakers with numbers 135-138, 142-144, 149-150 from the "J" box (tail cone) were recovered. No pre-impact anomaly was noted to the recovered electrical system components.

Figure 65 – Recovered wire bundle.

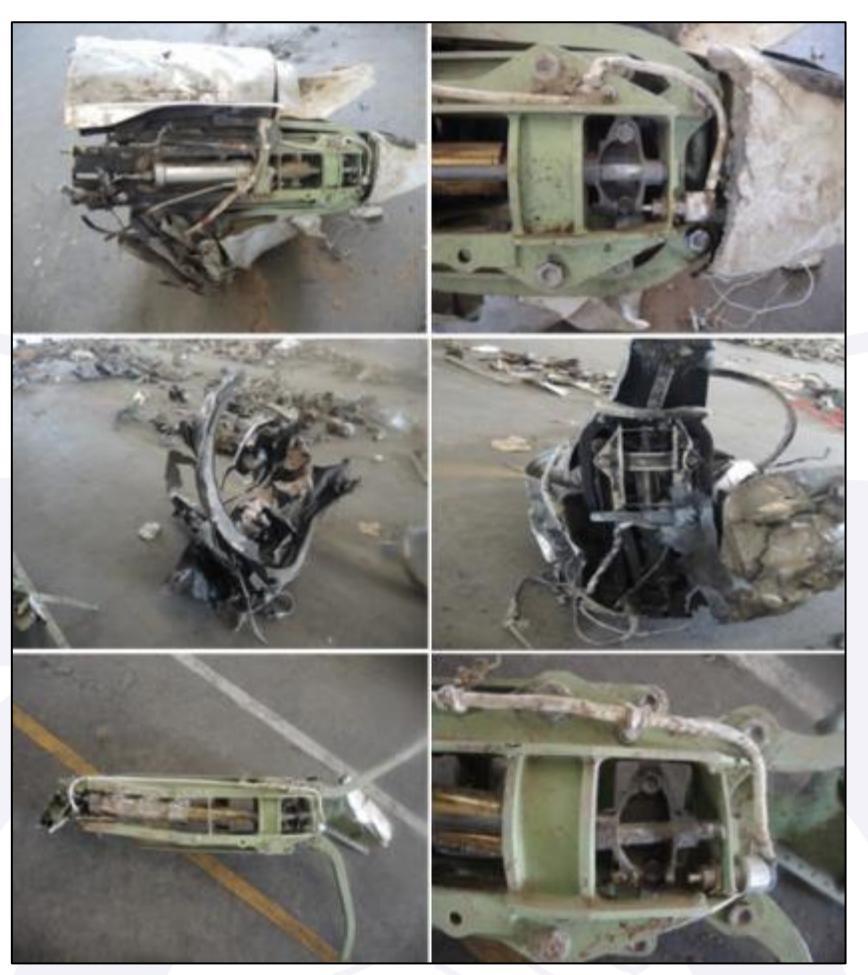
Both thrust reversers were separated and exhibited impact and fire damage. The hydraulic actuators for both were intact and in the overcenter (locked) or stowed position. No pre-impact anomalies were noted to the recovered thrust reverser components.

Figure 66 – Thrust Reverser Components.

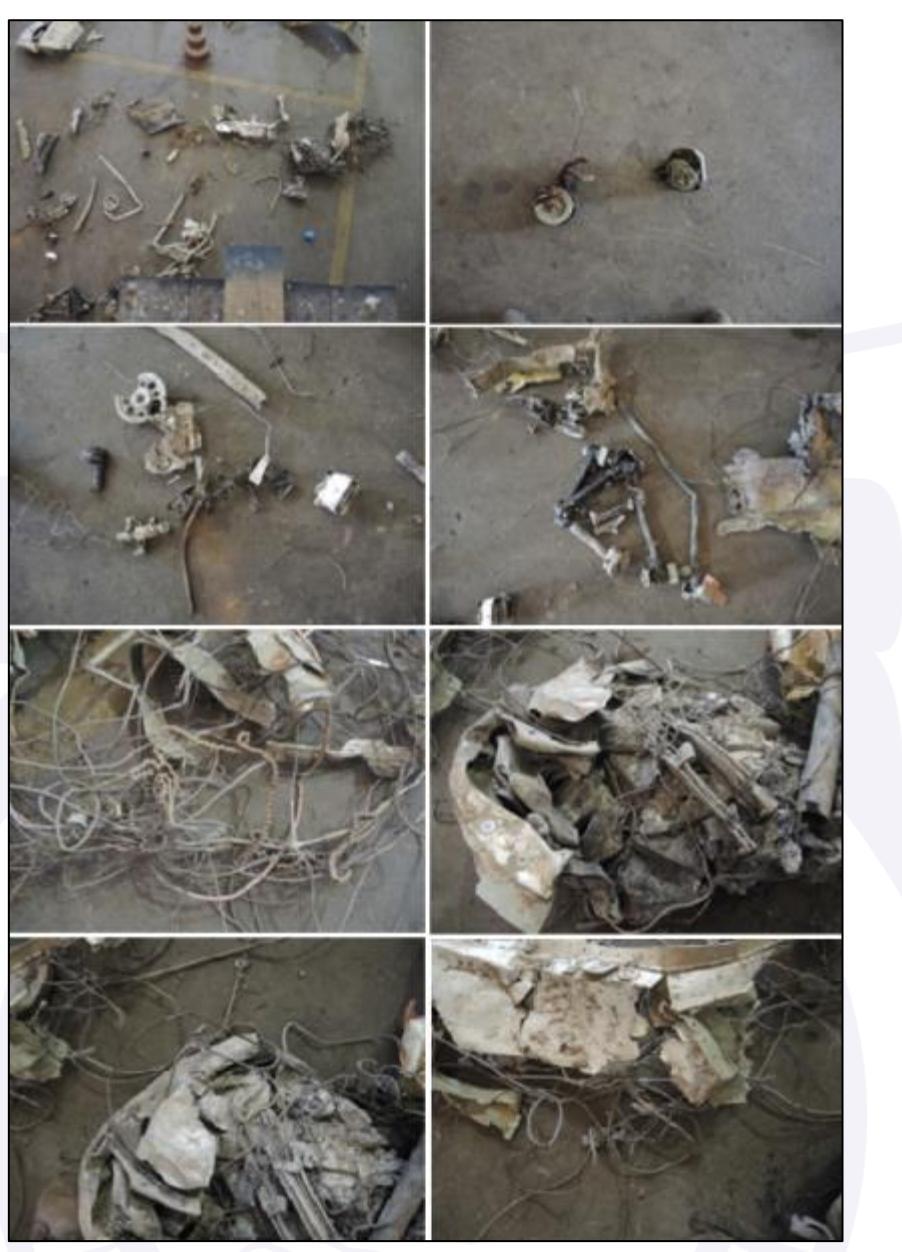
The flight control cable system was fragmented. The cables displayed multiple tension overload separations. The observed cable ends remained secured in their fixtures which include: turnbuckles, swaged fittings, clevis terminals, bridal cable clamps, and bell cranks.

All cable securing hardware consisting of nuts, bolts, etc., were observed in place and secure. No pre-impact anomalies were noted to the observed cable components.

Figure 67 – Flight Control Cables and Components.

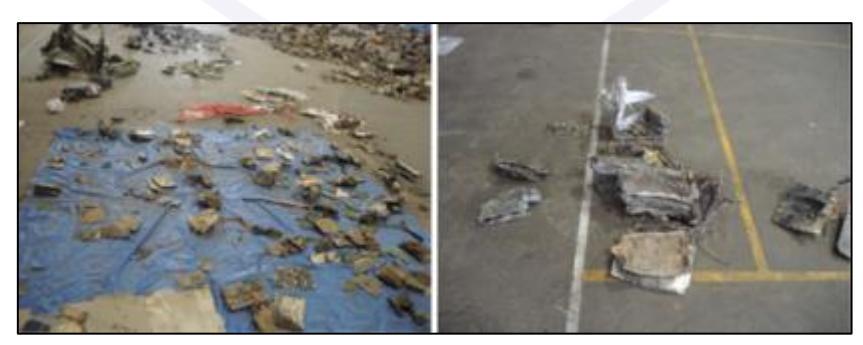
Avionics equipment that was recovered exhibited impact and fire damage. Most components were highly fragmented stripping the printed circuit boards from most boxes.

Figure 68 – Recovered Avionics.

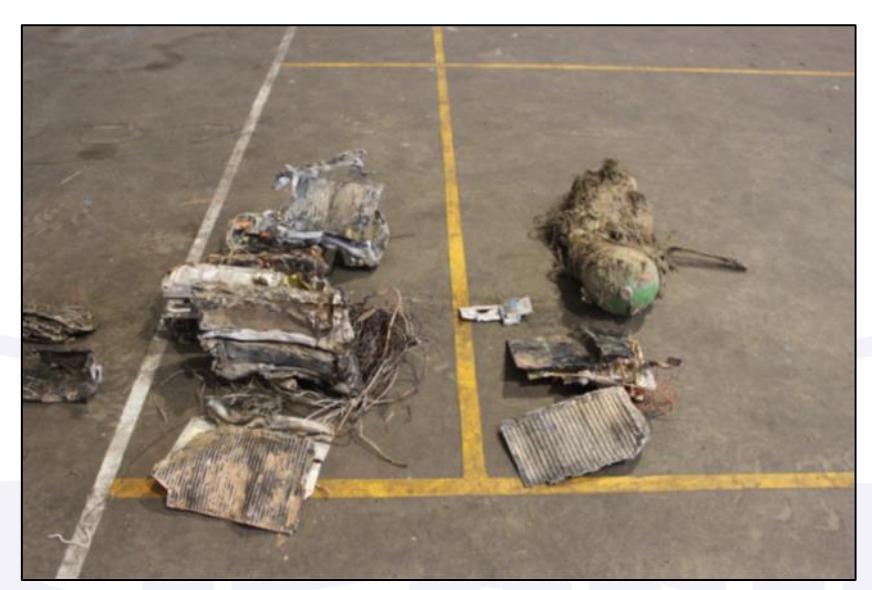
The only identified component of the Honeywell EGPWS consisted of an access door, and a portion of the case frame. No identifiable circuit boards attributed to the EGPWS were recovered. The CVR was recovered from the wreckage and sent to the CENIPA's LABDATA.

Figure 69 – Layout of the avionics on the front avionics bay. Front view: see the EGPWS cover to the left of the oxygen bottle.

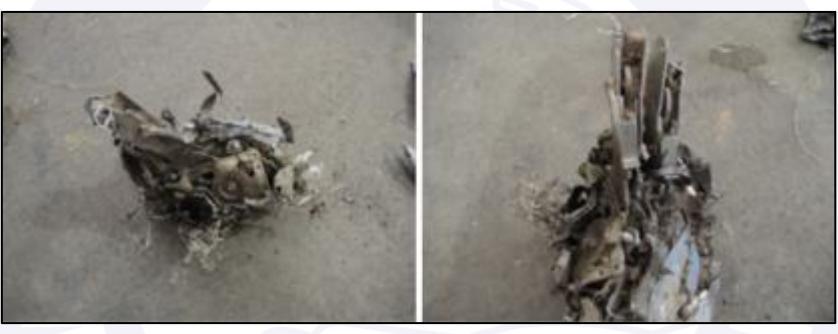
The throttle quadrant was damaged in the impact rendering the throttle positions unreliable. Both piggyback control levers were in the "stowed" position. The throttle levers were forward of the idle cutoff position. The right throttle lever was slightly forward of the left.

Figure 70 – Box of the throttles.

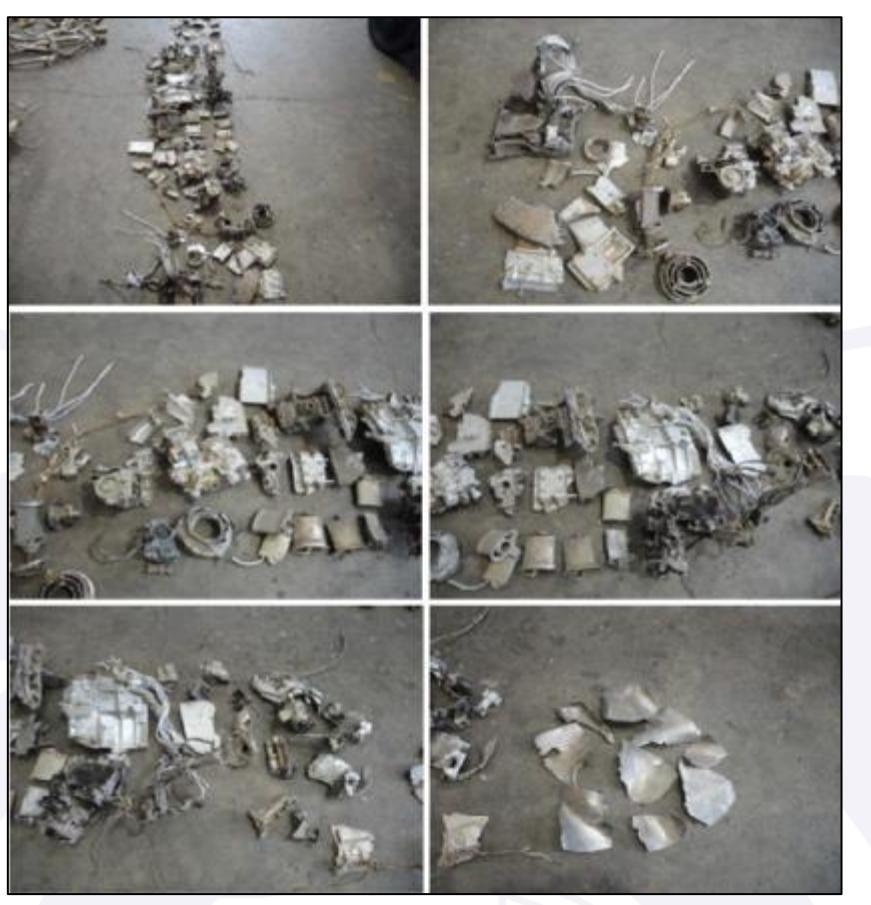
Both Fuel Control Units were fragmented. The N2 fans were fragmented; one separated from the drive shaft. The blades separated or were bent opposite direction of travel.

Figure 71 – Fragmented engine components.

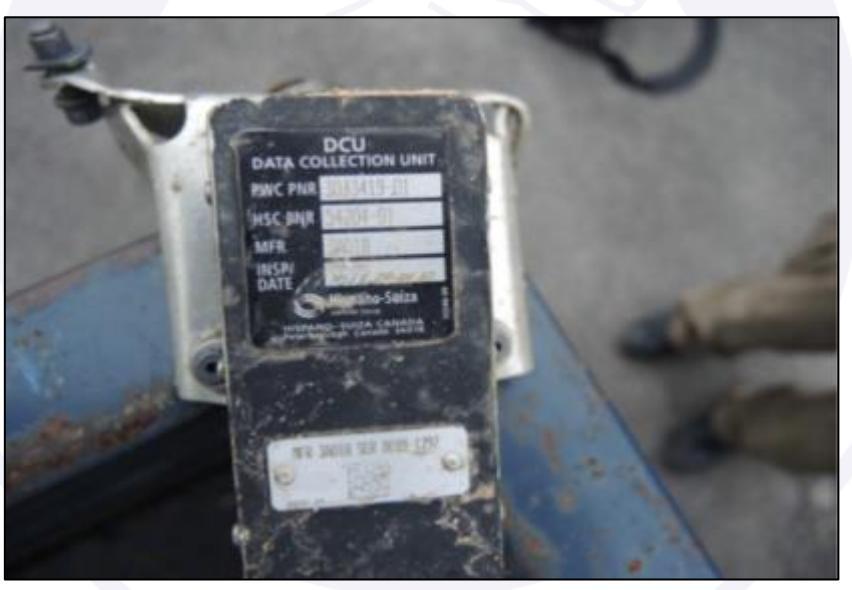
Only one FADEC unit was recovered; it exhibited impact and heat damage. The other FADEC was not recovered. One of two DCU's was recovered. It was impact damaged and will be returned to P & W for evaluation and data retrieval. One of two fuel filters and one of two hydraulic filters were recovered; the screens and bowls of both were clean and free of debris. Two of four igniter boxes were recovered with impact and thermal damage. The engines and identified separated engine components were sent to Sorocaba for examination by Pratt & Whitney representatives with CENIPA oversight. Data relative to the analysis of the engines are presented in the item 1.16 of this report.

Figure 72 – The only DCU (left engine) found amid the wreckage.

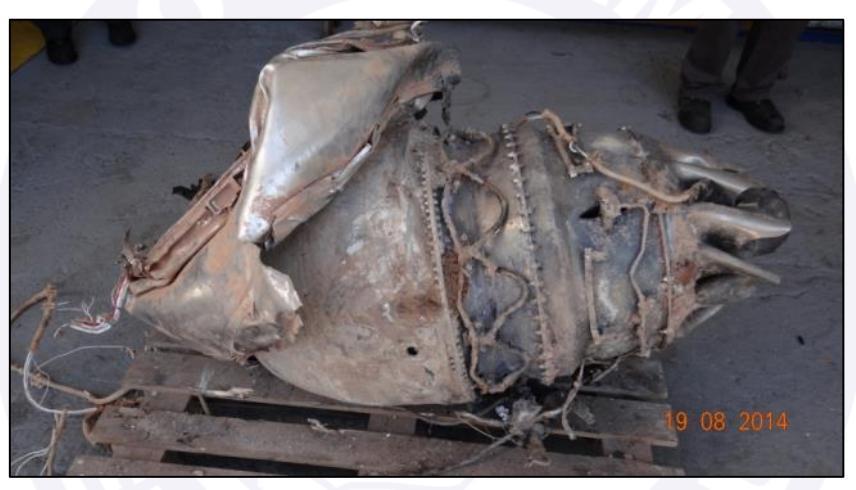
The engine separated into three distinct sections, as can be seen in the figures bellow due to the energy of the impact with the ground. Another observation is that the place where the engine nameplate was located was not found for identification. The engine was identified by the serial number of the fan disk, which was later compared with the engine logbook records.

Figure 79 – Left hand side view of the left engine.

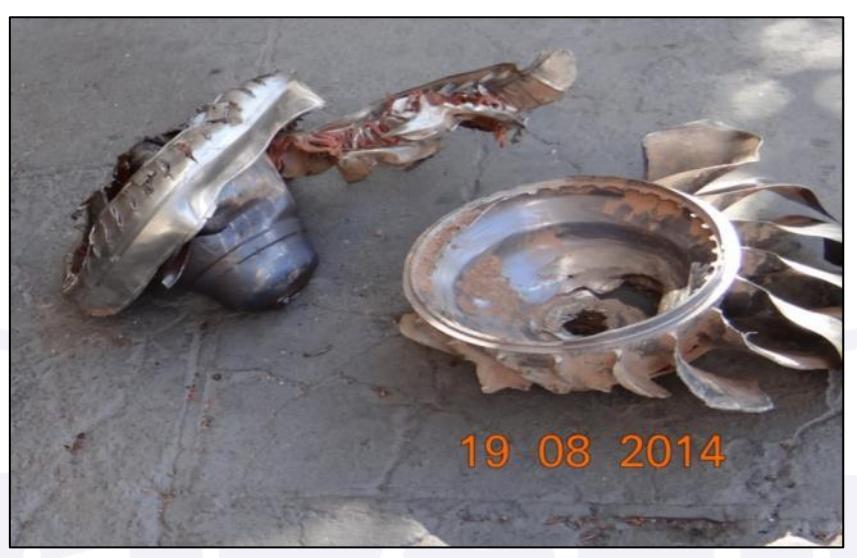
Figure 84 shows the inner side of the fan disk cone. In this figure, it is possible to observe the mark of intense rubbing and the disruption of its structure, in the central section. Figure 85 shows a closer view of the same cone, where one can see in more detail the damage to the rotary assembly and the disruption of the cone structure. Figure 86 shows a view of the torsion fracture of the fan disk drive shaft and low pressure compressor.

Figure 84 - View of the engine fan disk and part of the low pressure compressor.

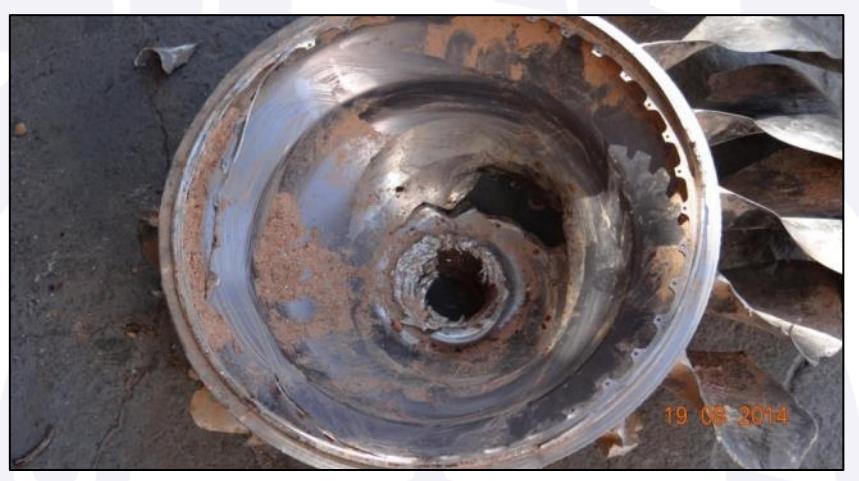
Figure 85 – Closer view of the internal part of the fan disk.

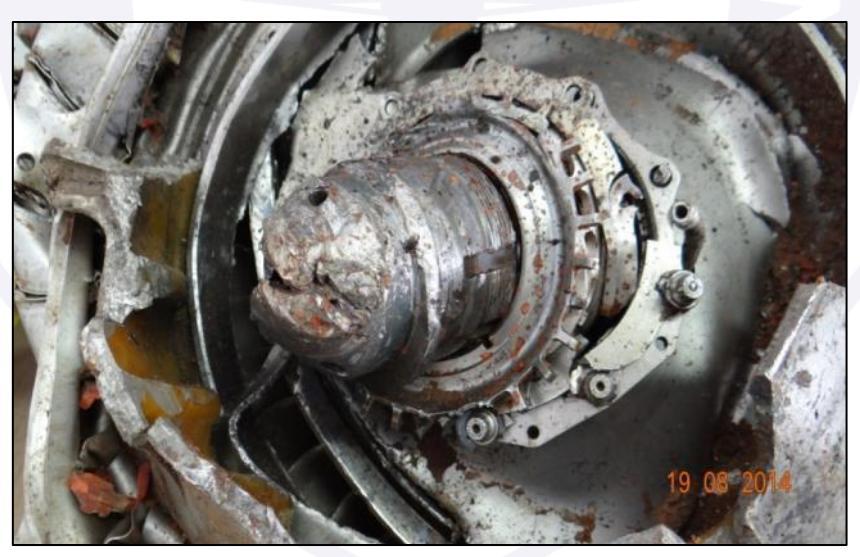
Figure 86 – View of the low pressure compressor and fan disk activation shaft.

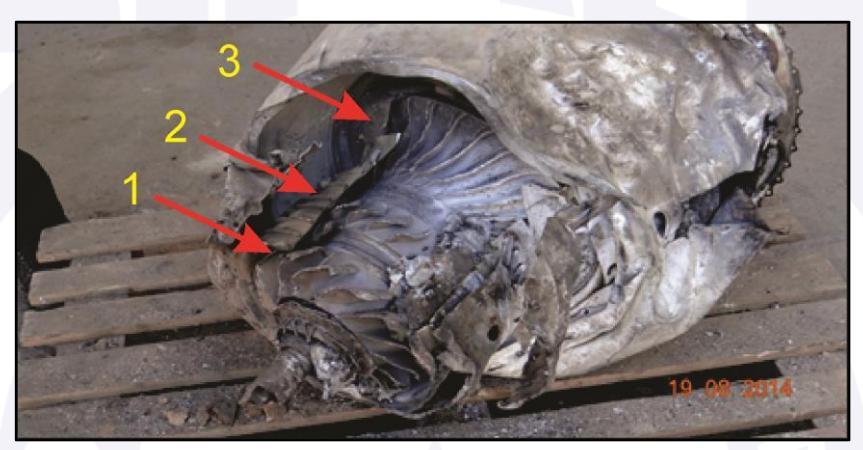
Through the cut made in their carcasses, it is possible to see the damage they suffered. The vanes of the three-stage high pressure compressor sustained severe damage, as can be seen in Figure 88. Figure 89 shows a front view of the axial stage of

Figure 88 – View of the high pressure compressor stages. (1) First axial stage; (2) Second axial stage; (3) Centrifugal stage.

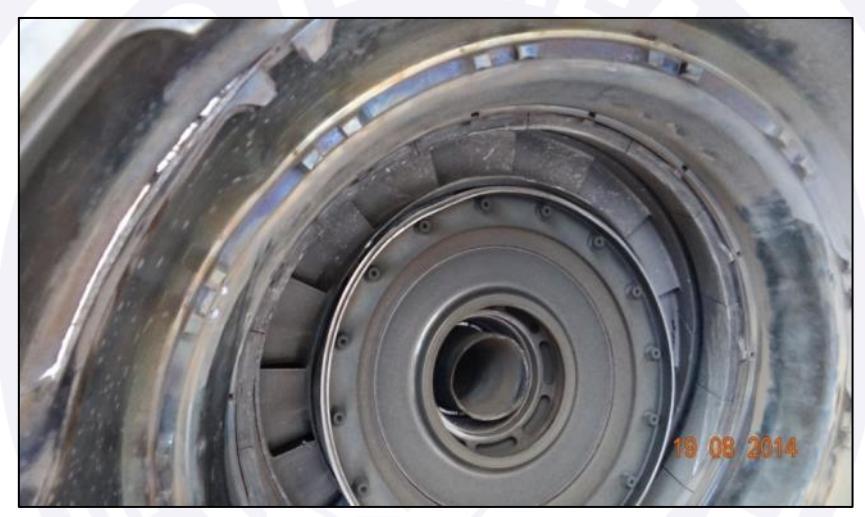
Figure 94 shows the stator of the high pressure engine compressor turbine. Marks of rubbing and impact were found, which were caused by the passage of fragments through the region of the vanes.

Figure 94 – General view of the high pressure compressor turbine stator.

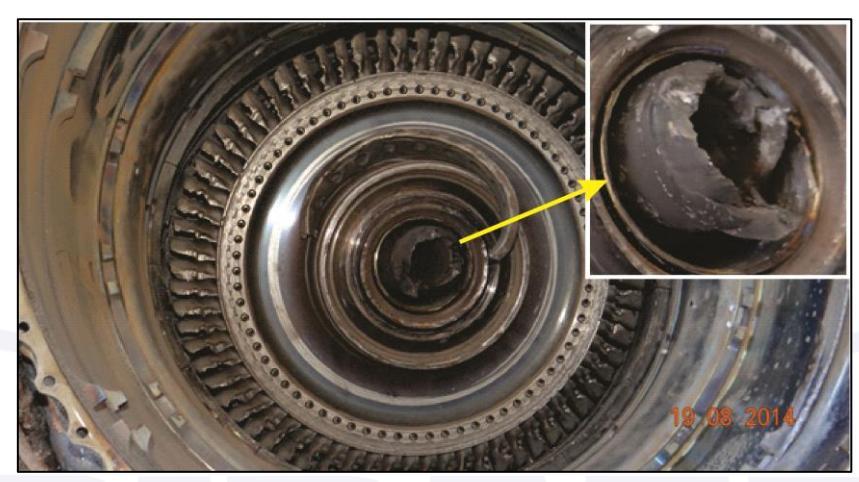
Figure 95 shows a back view of the high pressure compressor turbine rotor. It is possible to observe the marks of intense rubbing on the bodies and roots of the vanes and on the central part of the disk. The highlight shows the fracture found in the low pressure compressor and fan disk activationshaft. As can be seen, the surface of the fracture has an angle of 45 degrees.

Figure 95 – General view of the high pressure compressor turbine rotor. In highlight, a closer view of the fracture observed in the activation shaft of the low pressure compressor.

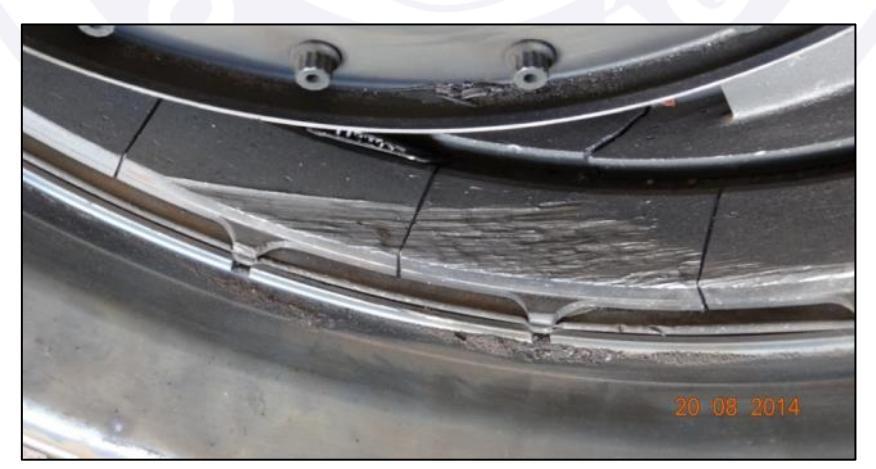
Figure 97 shows the marks of intense rubbing marks left by the edges of the vanes on the segmented ring. It is also possible to observe that there was misalignment of the rotating assembly due to the impact sustained by the engine.

Figure 97 – Mark of intense rubbing made by the rotor vanes on the sealing rings.

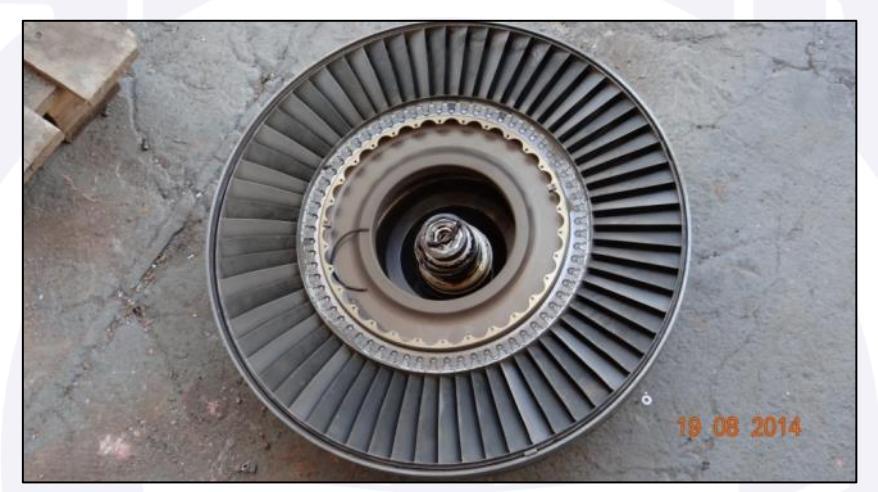
Figure 101 depicts a back view of the third stage low pressure compressor and fan disk turbine rotor. This rotor also had signs of mild rubbing at the roots of the vanes.

Figure 101 – Back view of the low pressure turbine third-stage rotor and fan disk.

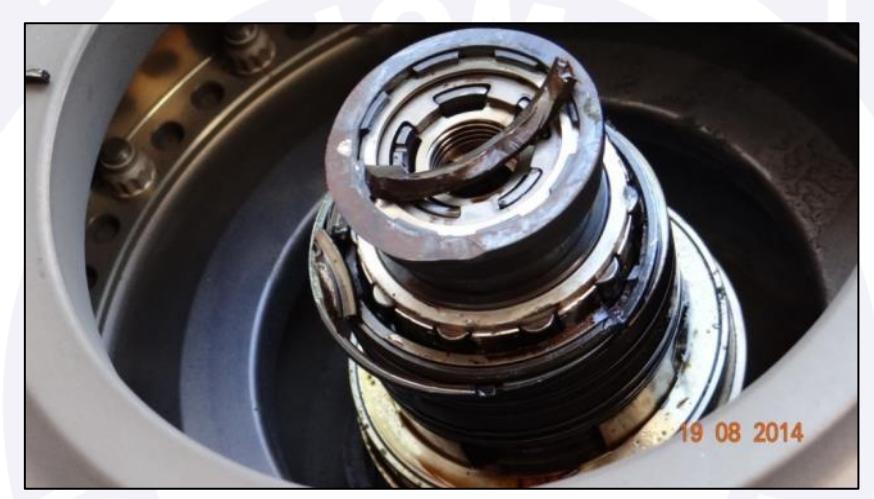
Figure 104 shows the rear bearing of the engine, in which no anomalies were found, such as lack of lubrication or damage to the rollers or tracks, which could cause malfunction.

Figure 104 – Close view of the rear bearing of the engine, undamaged.

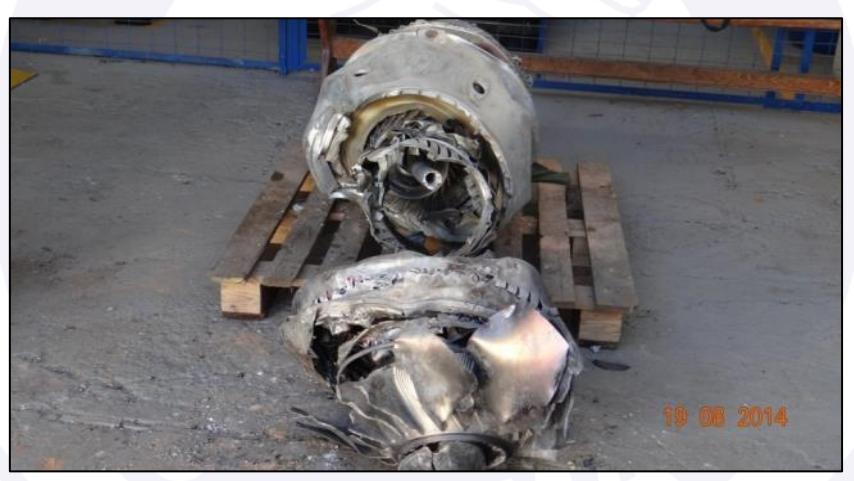
Figure 107 – Front view of the right engine.

Figures from 107 to 110 present views of the PW 545C engine, SN DF0135 (right). As can be seen, this engine also sustained damage from impact in a way similar to the one sustained by the left engine of the aircraft. It is possible to observe that this engine was broke up into three distinct parts.

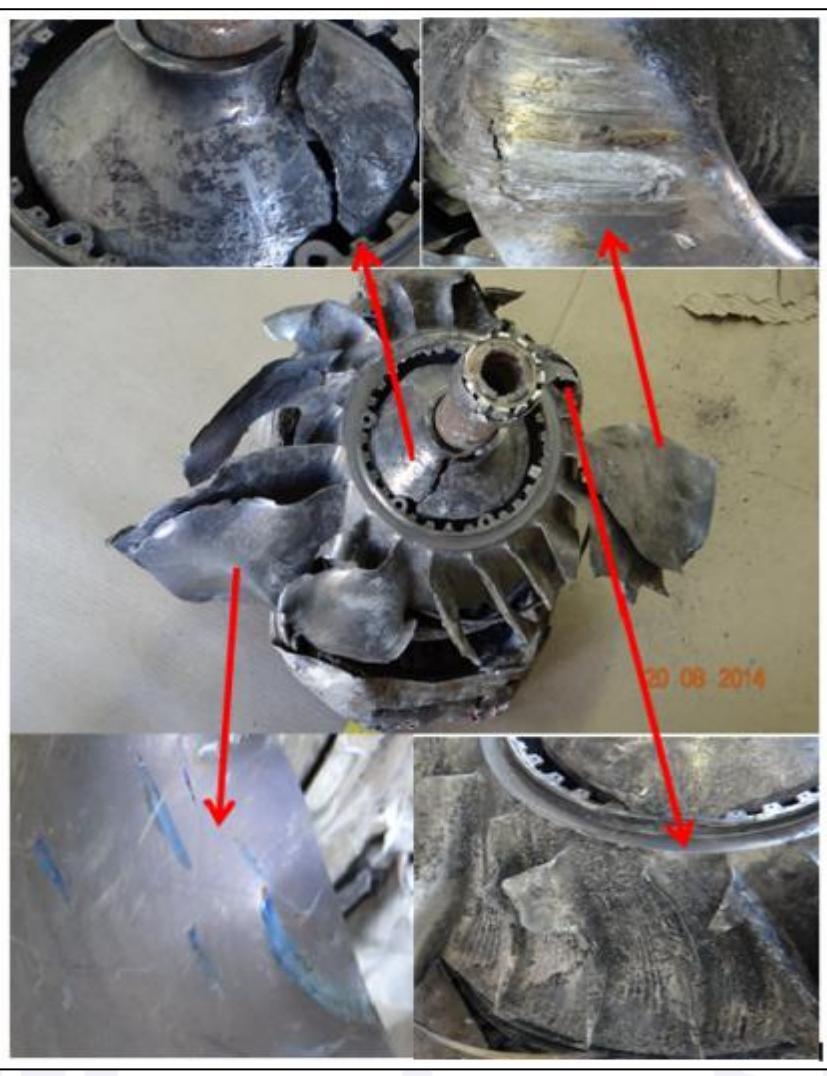
Figure 111 shows the fan disk of the engine. It had a broken cone and marks of intense rubbing, fractures and deformation of the vanes, as can be seen in the highlights.

Figure 111 – Views and details of the right engine fan disk.

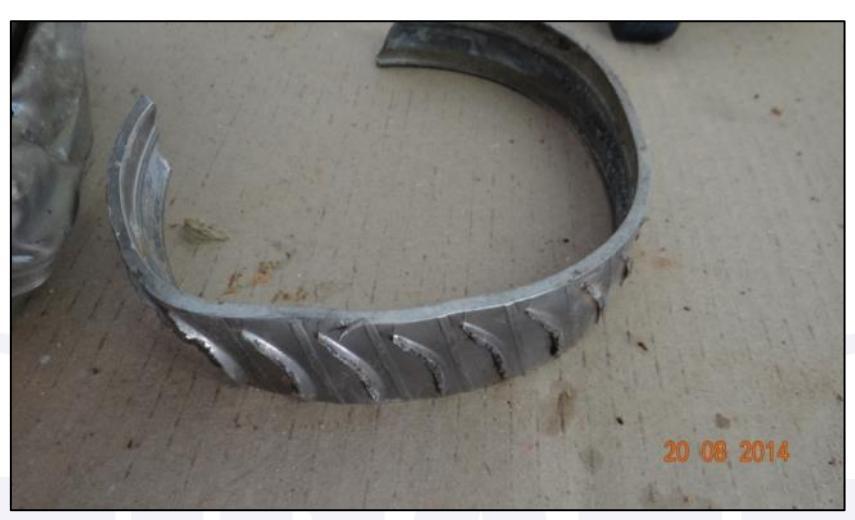
Figure 113 shows the inner ring of the same stator. Figure 114 presents a front view of the centrifugal stage rotor of the high pressure engine compressor. It is possible to observe that all impeller vanes were fractured.

Figure 113 – General view of the internal ring of the second stage of the high pressure compressor.

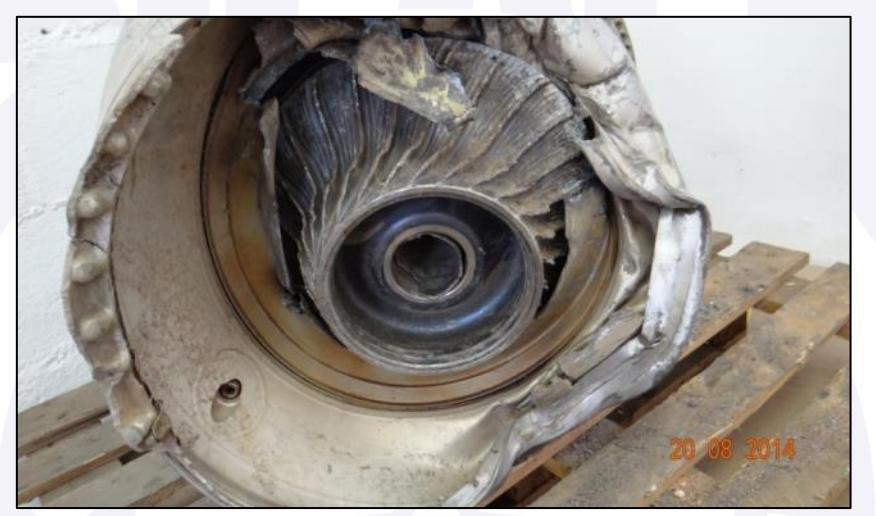
Figure 114 – Front view of the centrifugal stage rotor of the high pressure engine compressor.

Marks of intense rubbing were observed both on the disk and in the vanes. Figure 115 shows the detail of the rubbing observed in the vanes and their respective bases.

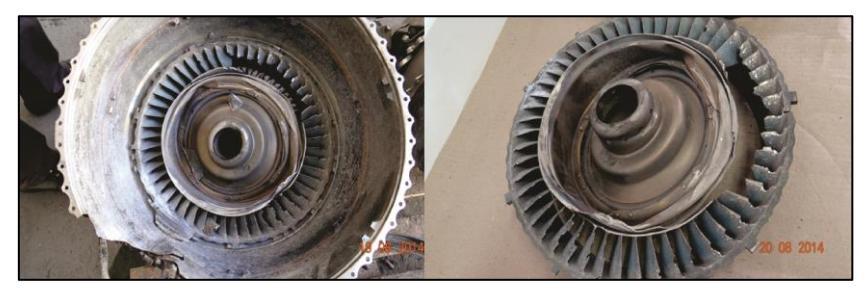
Figure 116 shows back views of the stator of the 1st stage of the low pressure compressorand fan disk turbine. It is possible to see that many vanes sustained rupture resulting from compression affecting the engine at the impact with the ground.

Figure 116 – Back view of the first-stage stator of the low pressure compressor turbine (left). Another view of the same stator, already segregated from the assembly (right).

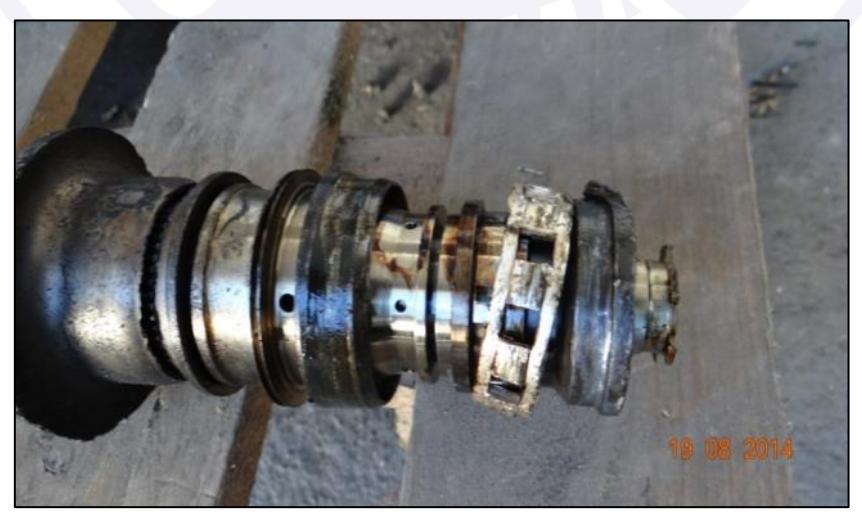
Figure 121 shows the shaft with the rear bearing of the engine. It had no anomalies capable of having caused engine malfunction.

Figure 121 – View of the low pressure compressor activation shaft and of the engine bearing 5.

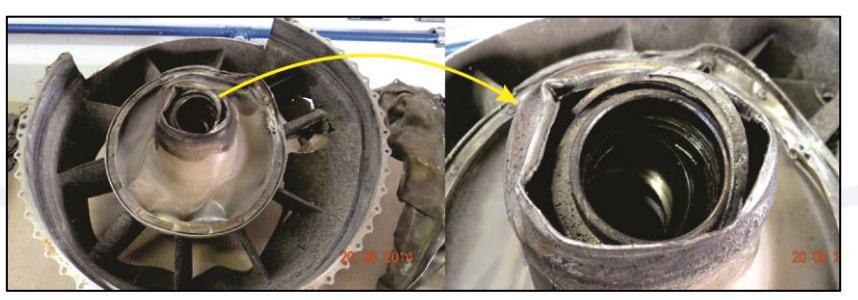
In a way similar to the left engine, lubricant oil residues were found inside the housing of bearing 5. When the engine stopped after the collision, the lubricant oil leaked in the engine rear support, as shown in Figure 122.

Figure 122 – General view of the rear support of the engine with signs of lubricant oil leakage (left). Detailed view showing the housing of the engine bearing 5 (right).

The analysis of the aircraft left engine (PW 545C, SN DF0135, 434.5 Hours Since New, 400 Cycles Since New) revealed that it was severelydamaged upon colliding with the ground.

Since the characteristics of the damage found in the right engine are similar to the one sustained by left engine, all the comments and analyses can be equally applied to both engines.

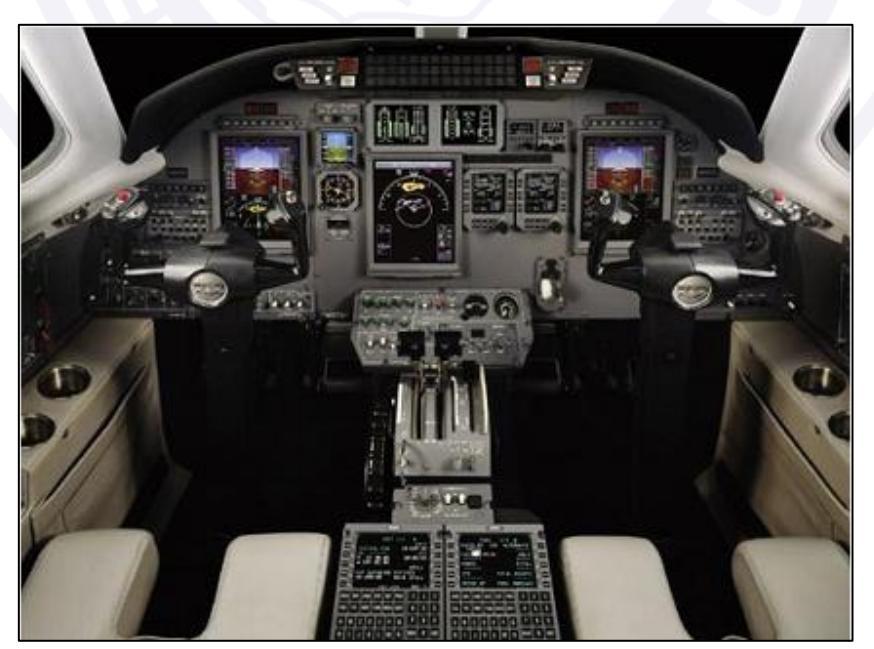
Figure 125 – Picture of theCE 560XLS panel (Honeywell Primus 1000 avionics) operated in earlier times by the captain.

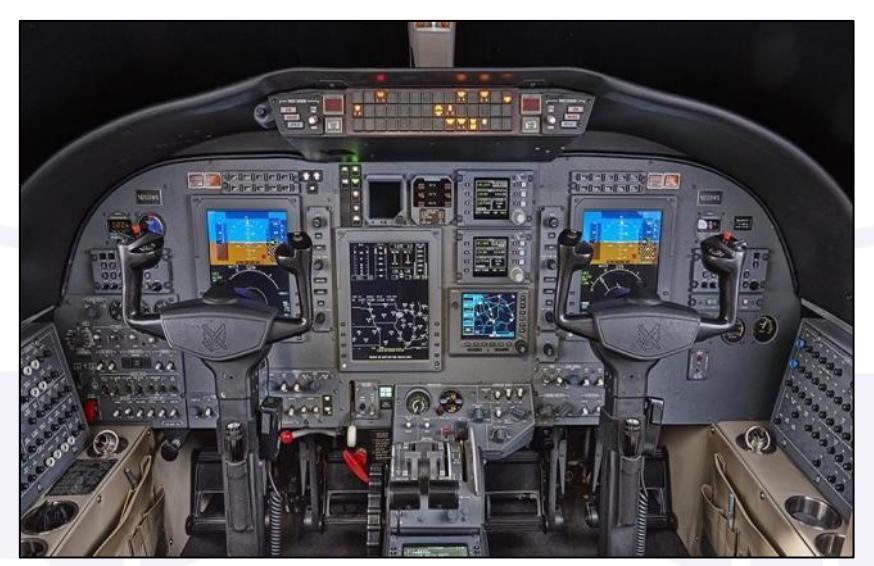
Figure 126 – Picture of the C560Encore+ panel (Collins Pro Line 21 avionics) operated in earlier times by the copilot.

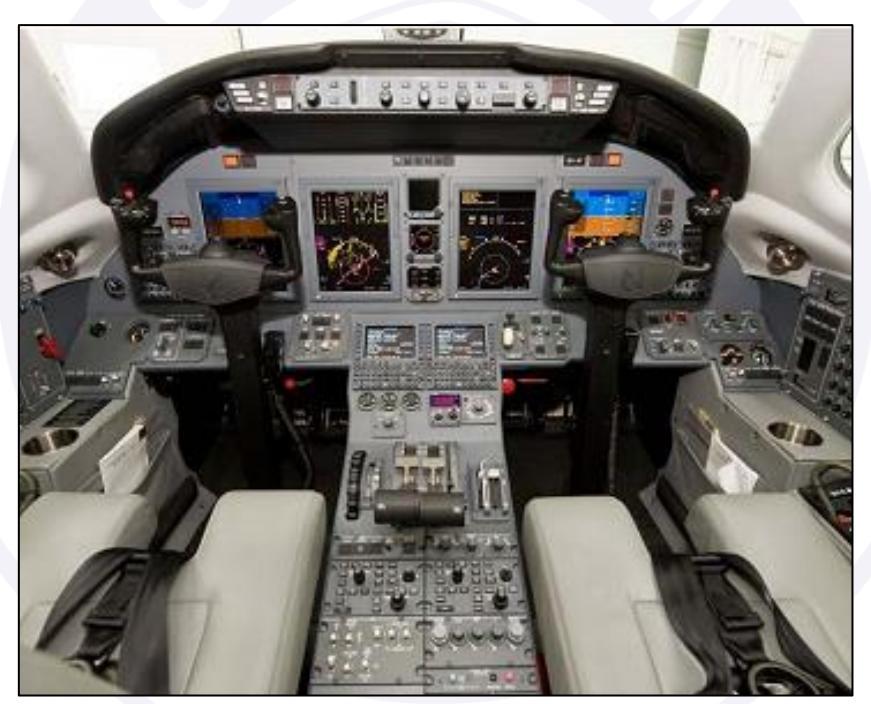
Figure 127 – Picture of the CE 560XLS+ panel (Collins Pro Line 21 avionics) which was being operated at the moment of the accident.

The differences identified by the FAA (Primary Certification Authority of the State of Manufacturing and Design) which justified the need of specific training for adaptation to the CE 560XLS+ model, led the investigators to infer that pilots flying different aircraft models without proper training might be submitted to difficulties in the operation of the aircraft systems.

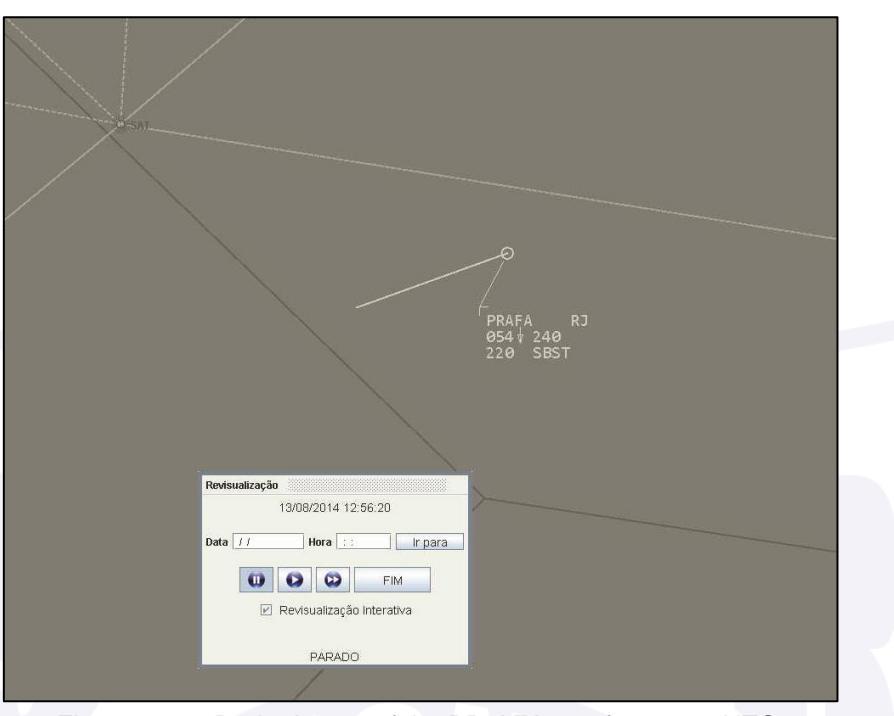
In the 12:56:20 UTC radar image, it is possible to see that, after coordinating its descent, the PR-AFA made a left turn, moving away from the W6 airway, and descended to an altitude below FL060, as shown in Figure 135.

Figure 135 – Radar image of the PR-AFA as of 12:56:20UTC.

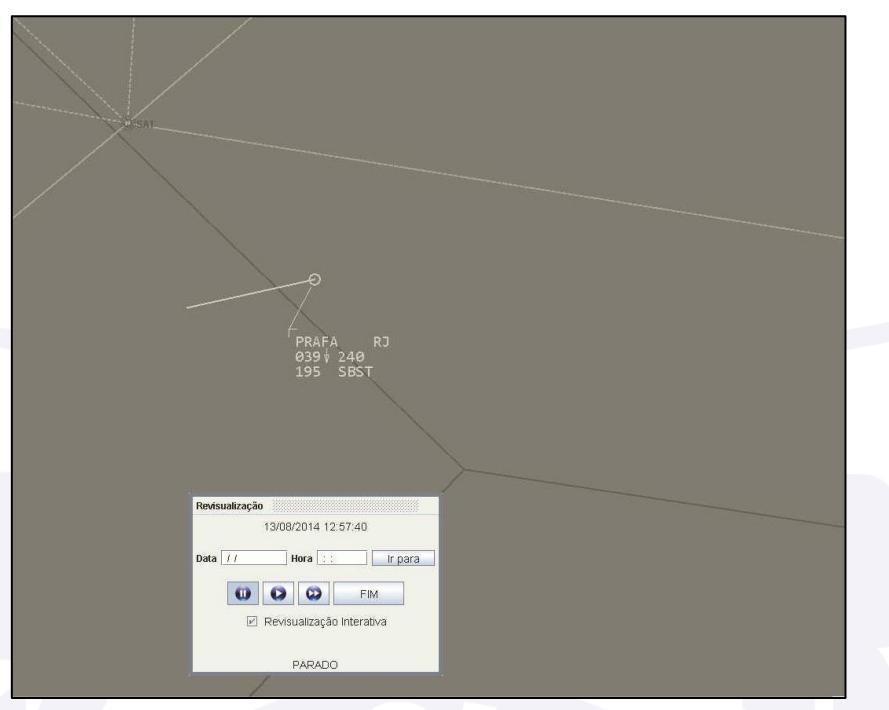
However, the message was not compatible with the 12:57:40 radar image, which showed the aircraft to the left of the W-6 airway and below the minimum prescribed altitude for starting the procedure (Figure 137).

Figure 137 – Radar image of the PR-AFA as of 12:57:40 UTC, showing the aircraft to the left of the W6 airway, away from the prescribed position for crossing SAT NDB, passing the altitude of 3,900ft while descending.

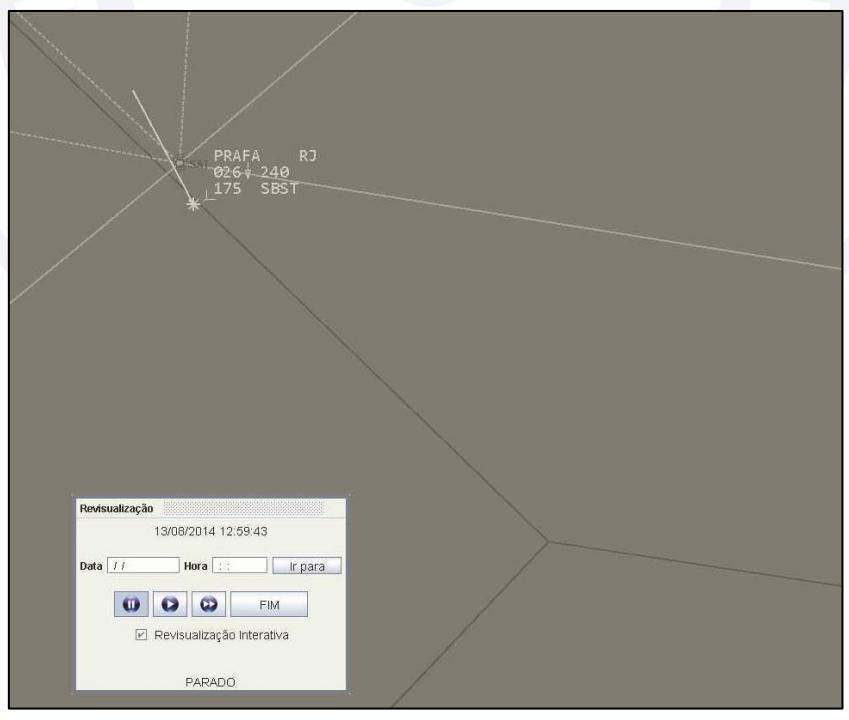
At 12:59:43, the radar generated the last (extrapolated) position of the PR-AFA on the approach to runway 35, at a distance of one nautical mile from SAT NDB, when altitude and speed data are no longer considered reliable (Figure 140).

Figure 140 – Radar image of the PR-AFA as of 12:59:43 UTC.

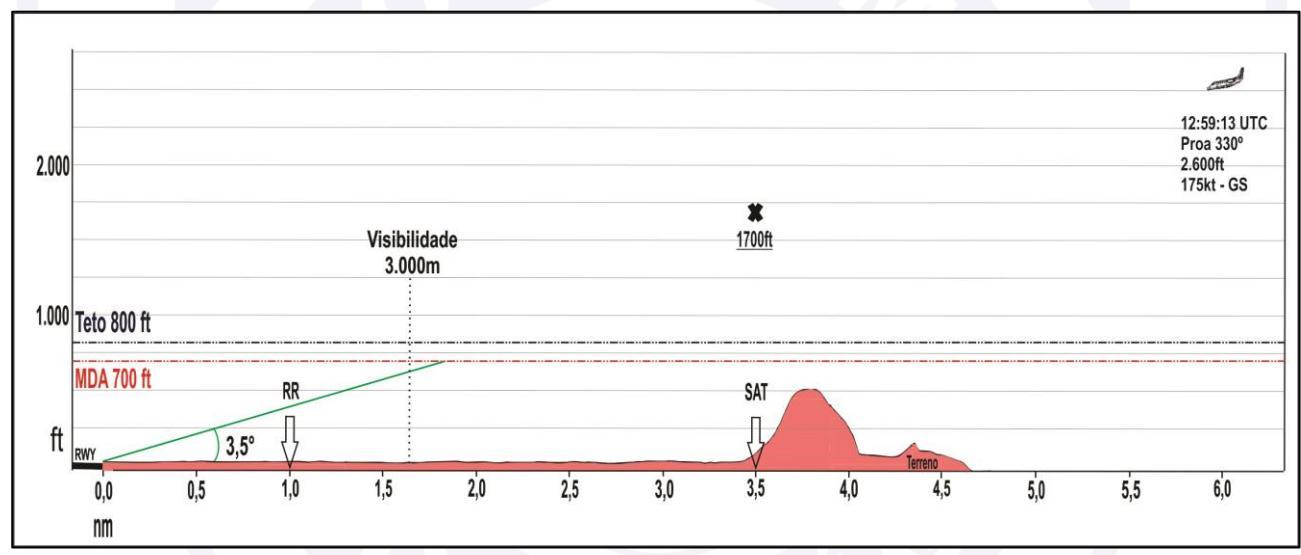
By associating the aircraft position data generated by the radar at 12:59:43 with: -the vertical profile of the terrain on the final approach; - with the MDA and SAT NDB crossing limits; - the projection of a final approach path towards runway 35 at an angle of 3.5°; and - the ceiling and visibility data reported in the METAR, it is possible to determine the scenario represented in Figure 144.

Figure 144 – Vertical Profile of: - the meteorological conditions; - ECHO 1 procedure restrictions, and - aircraft position detected by the radar at 12:59:13UTC (not to scale).

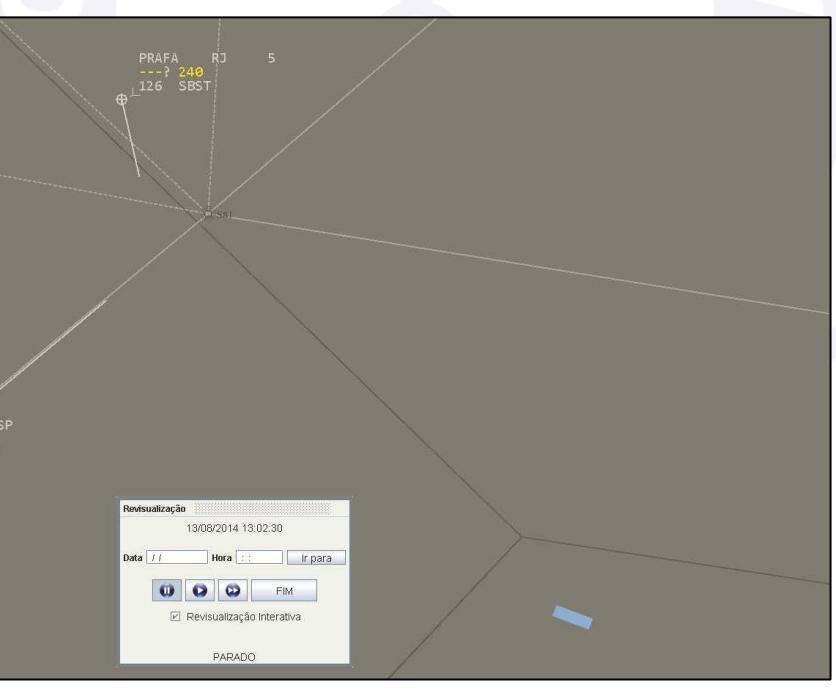
At 13:02:30, the radar generated an image showing the aircraft in the west sector of the aerodrome, but without sufficient accuracy to determine its position, height or speed (Figure 152).

Figure 152 – Radar image of the PR-AFA as of 13:02:30UTC.

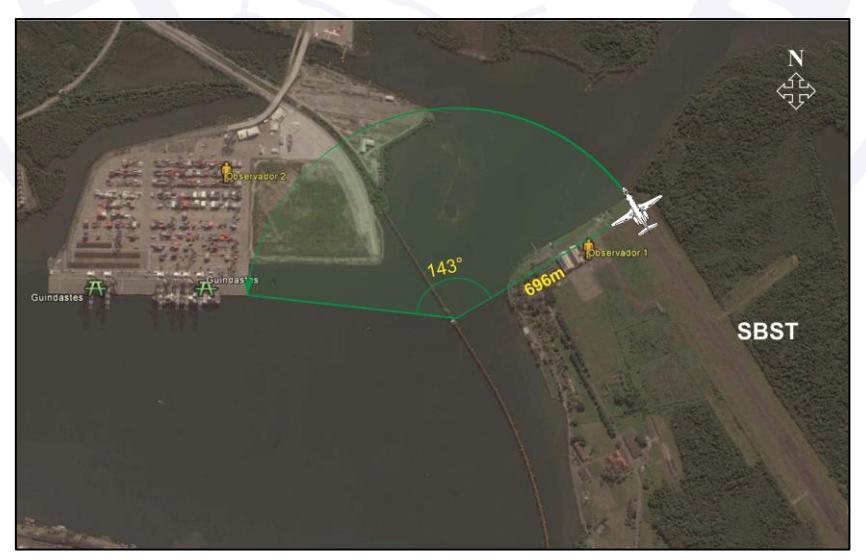
Taking into consideration the distance between the runway 17 threshold and the area of the Port where the cranes are located, an arc of 143 degrees with a radius of 696 meters was estimated, which defined a region through which the aircraft might have traveled (Figure 154).

Figure 154 – Representation of the observers' position, cranes location in the Port of Santos, the runway location, and turn made by the aircraft according to the observers.

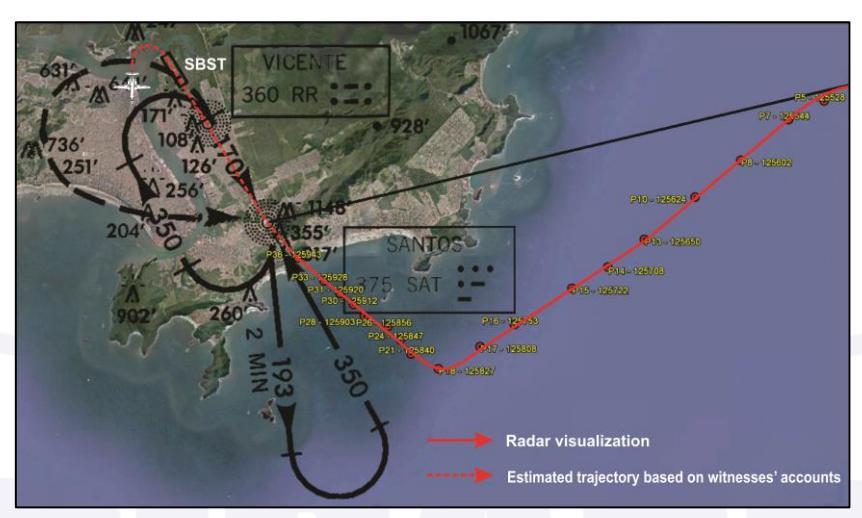
For reconstruction of the trajectory flown by the aircraft, the investigators considered the data obtained by radars, the data retrieved from the left engine DCU, and the information provided by observers on the ground. The following trajectory was determined up to the point where the aircraft disappeared in the clouds (Figure 156).

Figure 156 – Profile flown by the PR-AFA based on the radar visualization and accounts by observers on the ground.
