# COMANDO DA AERONÁUTICA <u>CENTRO DE INVESTIGAÇÃO E PREVENÇÃO DE</u> <u>ACIDENTES AERONÁUTICOS</u>

# FINAL REPORT A - 134/CENIPA/2014

OCCURRENCE: AIRCRAFT: MODEL: DATE: ACCIDENT PR-AFA CE 560XLS+ 13AUG2014

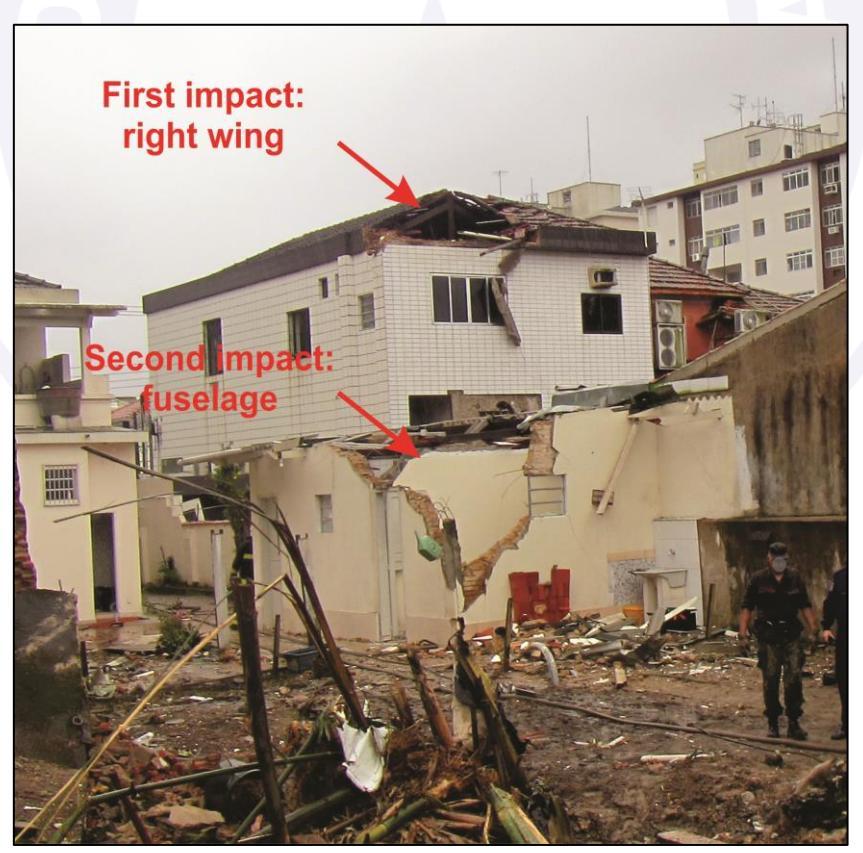
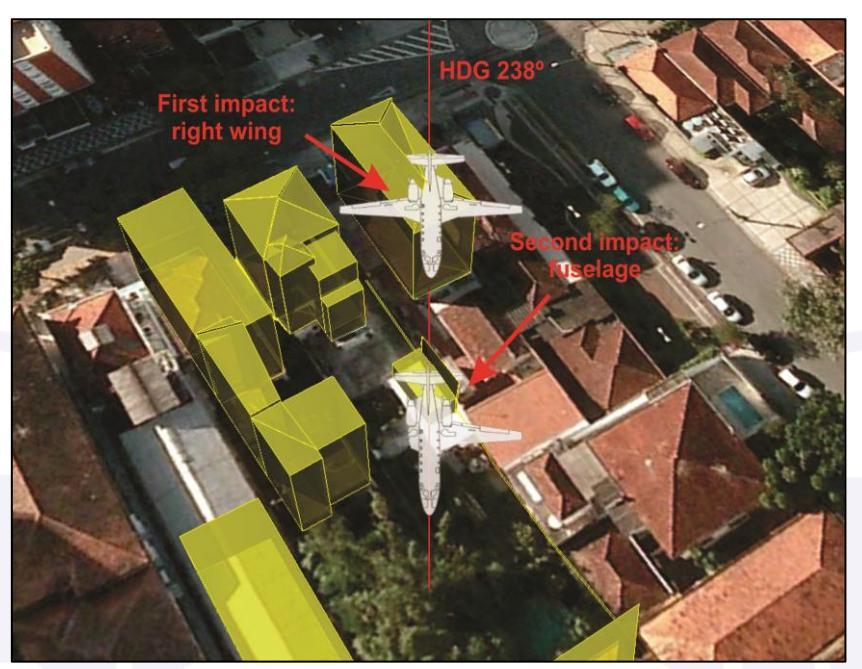
Considering the arrangement of the buildings in the terrain and the information obtained from the analysis of the aircraft wreckage, the investigators concluded that the first part of the aircraft which collided with the roof of the building was a wing section next to the right wing root, while the fuselage hit a small house. From this observation, the aircraft heading was estimated to be 238° at the moment of the collision (Figures 157 and 158).

Figure 157 – Position of the first impacts of the aircraft with the buildings.

Figure 158 – Reconstruction of the first impacts for determining the aircraft heading before the crash.

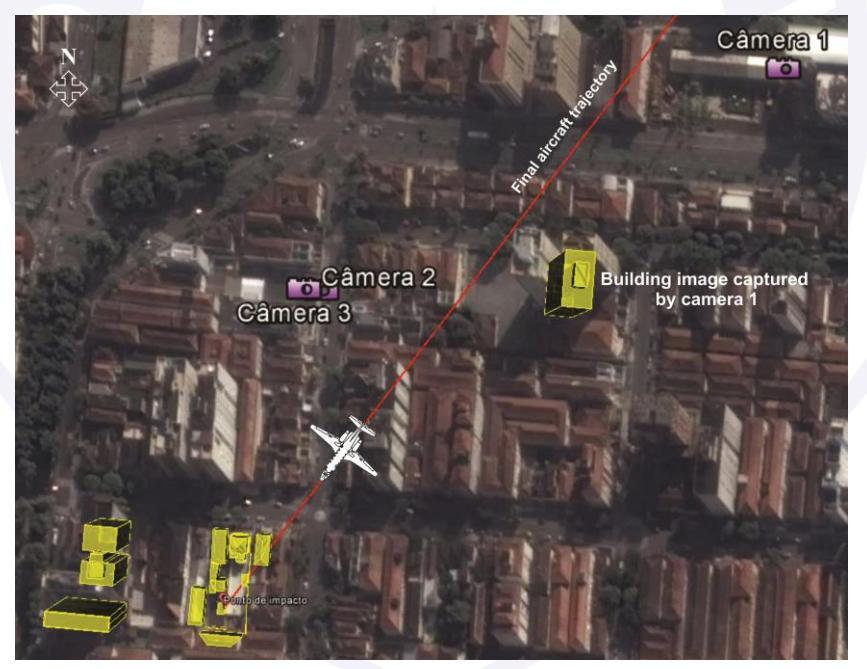
The second and third videos were recorded by two 30-FPS security cameras located on *Vahia de Abreu* Street (cameras 2 and 3), as shown in Figure 159.

Figure 159 – Position of the cameras in relation to the aircraft trajectory toward the point of impact.

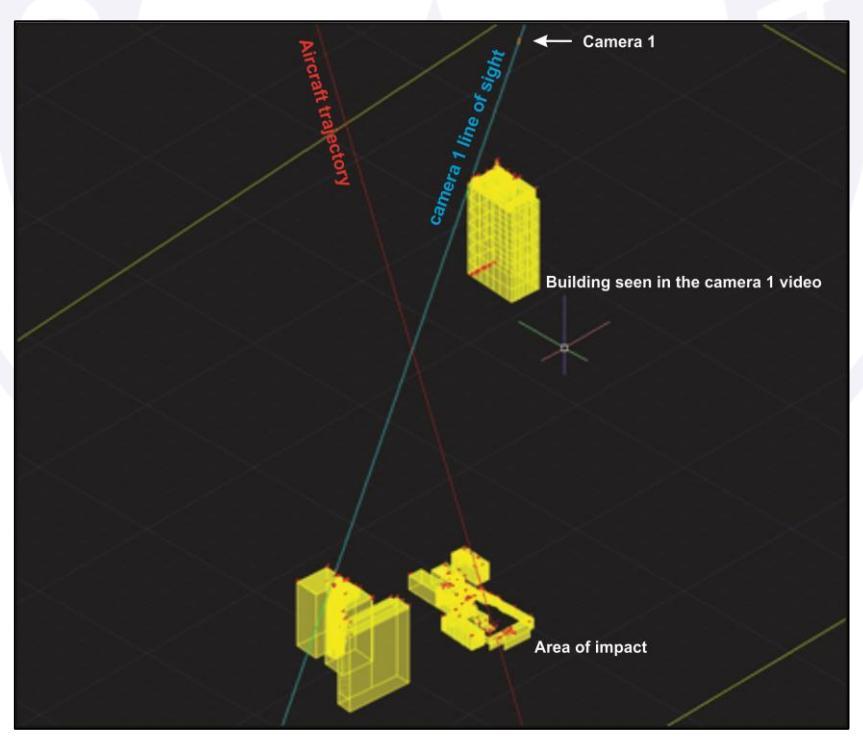
Considering that the aircraft flew along a straight line between the area of impact and the locations shown in the images recorded by the cameras, it is possible to project a red straight line to represent the possible trajectory flown by the aircraft, and a blue straight line representing the line of sight from camera 1, which is tangential to the building observed in the images (Figure 163).

Figure 163 – Geo-referenced reconstruction of the main points for calculation of the aircraft trajectory and speed.

The angle formed between the trajectory vector and its projection on the plane of the terrain was then measured, resulting on a range of possible values due to the uncertainties associated with an estimated vertical trajectory angle ( $\gamma = 35 \pm 5^{\circ}$ ).

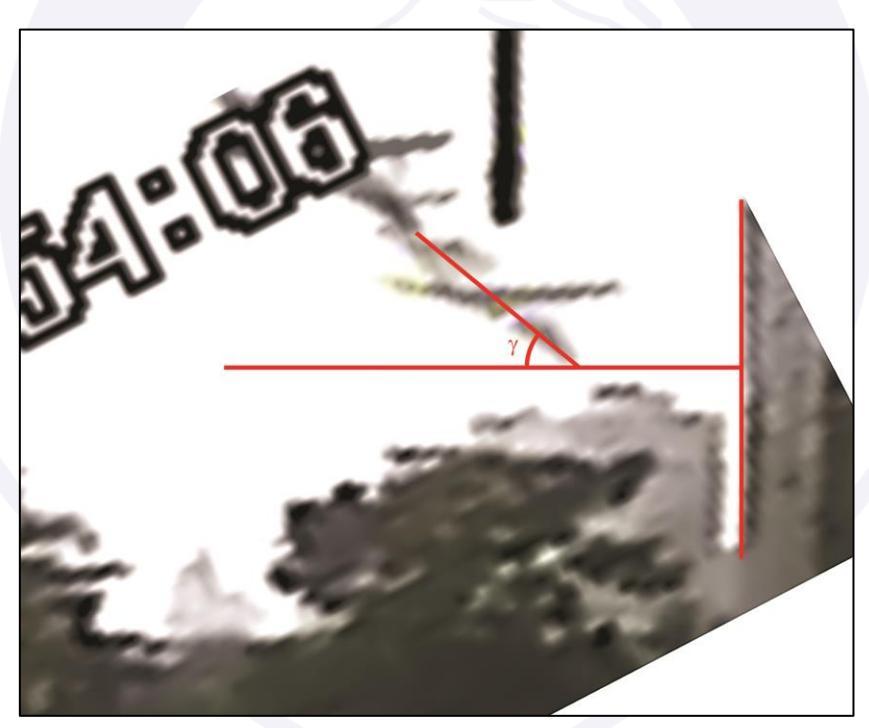
The angle formed between the line corresponding to the aircraft trajectory and the line of the horizon was then measured and, after correction of this angle on account of the aircraft position, the value obtained was  $\gamma = 22,4^{\circ}$ .

Figure 164 – Measurement of the angle from the building (camera inclination has been corrected).

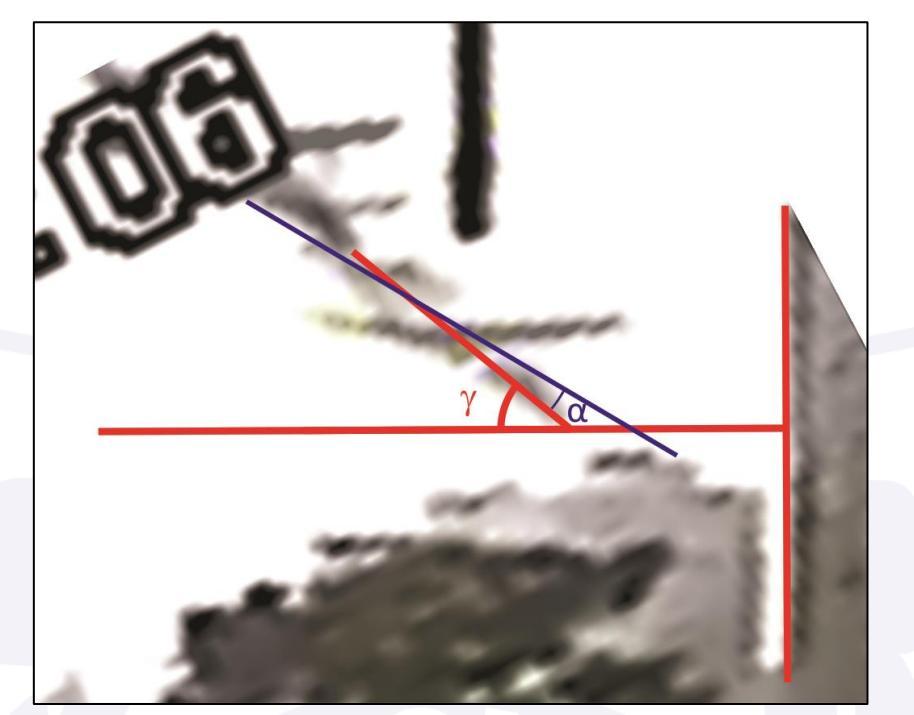
The image recorded by camera 2 made it possible to measure the angle formed between the longitudinal axis of the aircraft and the line of the aircraft trajectory. After correction of the angle on account of the aircraft position, the resulting angle of attack in relation to the camera line of sight was  $\alpha = 5.7^{\circ}$  (Figure).

Figure 165 – Measurement of the pitch angle from the projection of the aircraft movement.

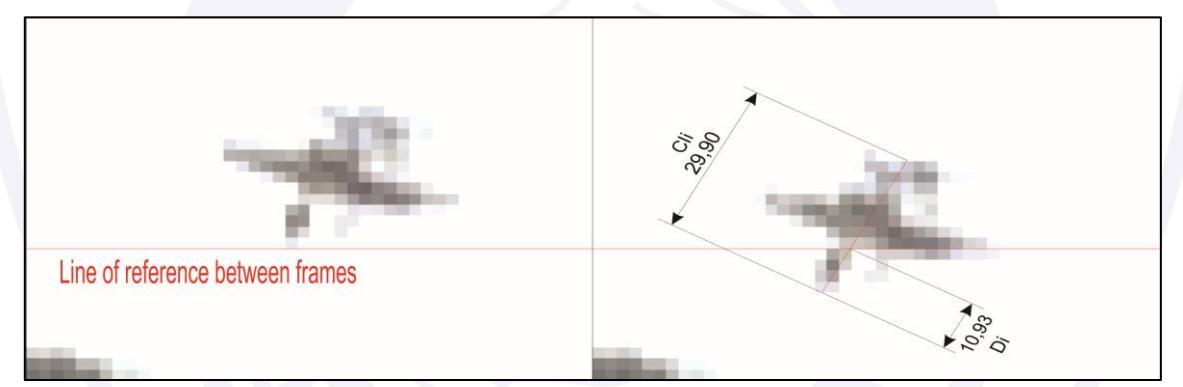
For calculating the speed, one measured the movement of the aircraft in relation to two consecutive frames and, also, the length of the aircraft shown in the images recorded by camera 1 (Figure 166).

Figure 166 – Movement between frames of the camera 1 image.

Thus, the estimated aircraft speed was 175.46 m/s, corresponding to 341 kt.

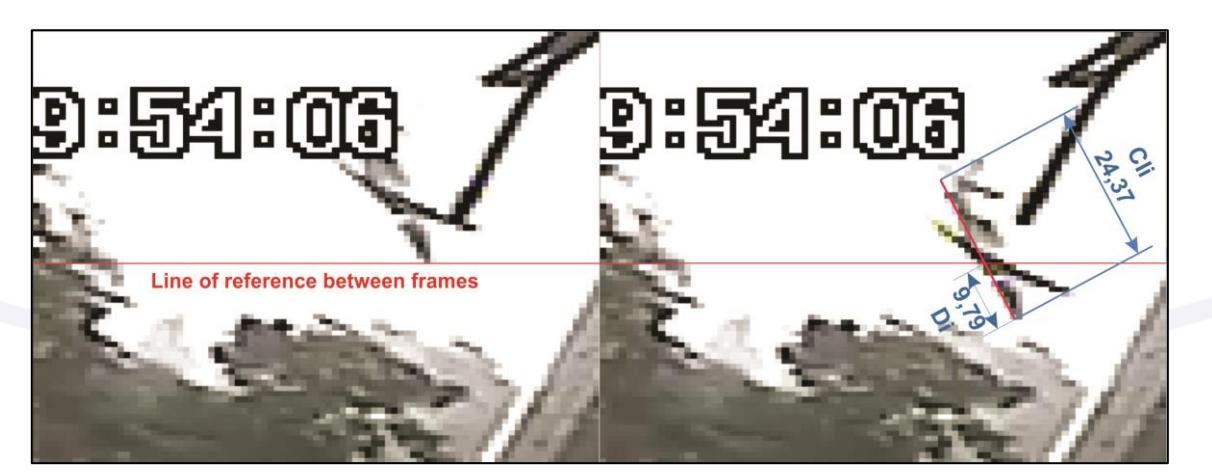
With utilization of the same calculation method for the camera 2 images, one verifies the following:

Figure 168 – Movement between frames of the camera 2 image.

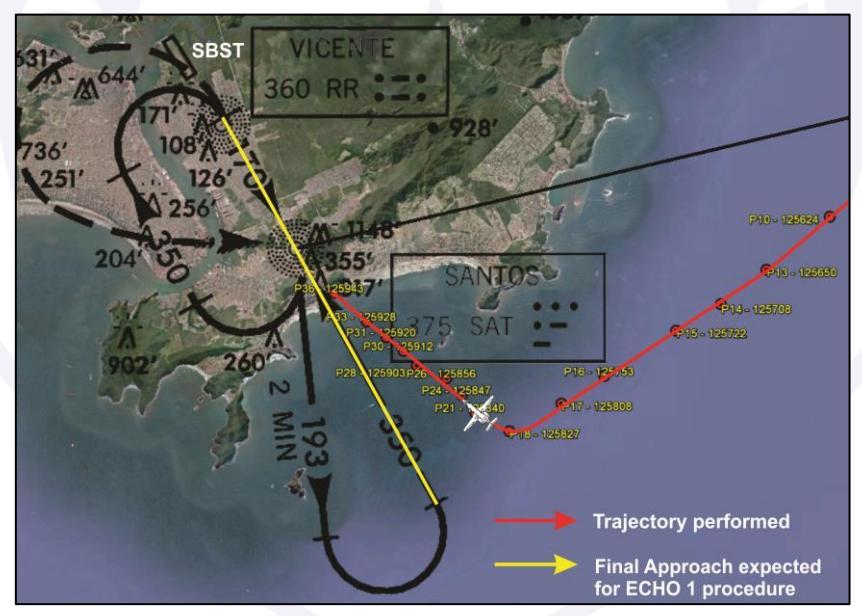
According to the radar visualization, the final approach trajectory flown by the aircraft differed from the trajectory defined for the profile of the ECHO 1 procedure, i.e., the aircraft stayed to the right of the prescribed trajectory, as shown in Figure 170.

Figure 170 – Profile flown by the PR-AFA based on the radar visualization, in comparison with the profile prescribed in the ECHO 1 procedure.

Taking into consideration a number of accounts of other direct approaches made by the captain utilizing FMS resources for visual approaches, and also considering the difference of the profile of the ECHO 1 final approach in relation to the radar images, the commission raised the hypothesis that the crew might have utilized the FMS visual approach mode with the objective of entering a direct final approach for landing on runway 35 in SBST. The fact that the crew reported being in VMC conditions reinforces such hypothesis.

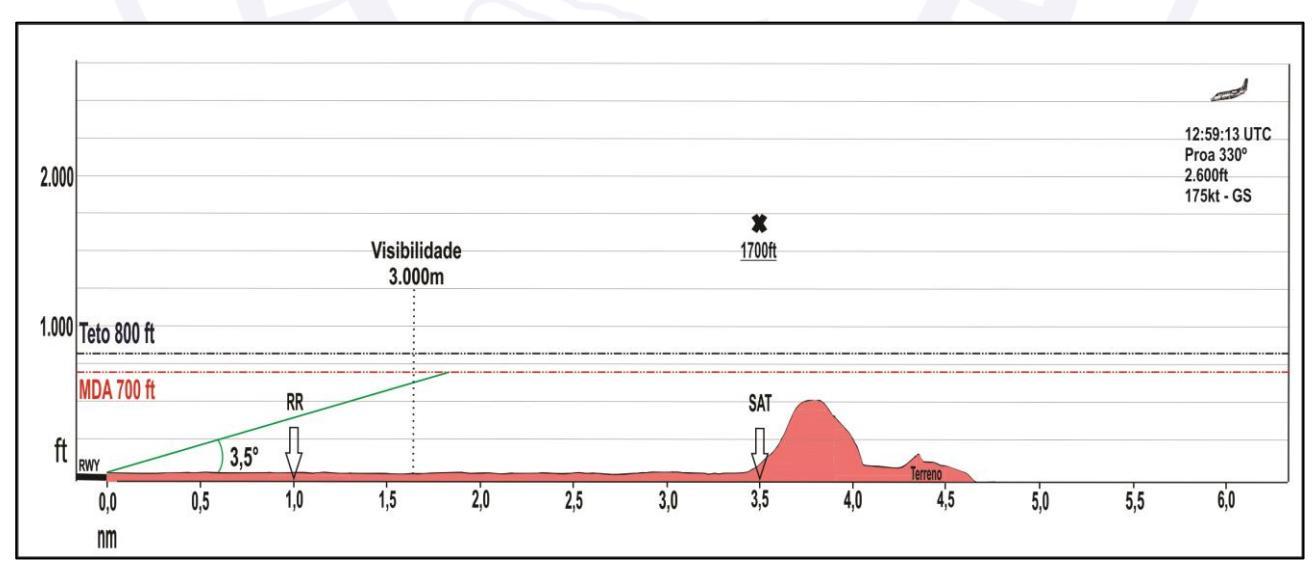
The last non-extrapolated radar visualization on the radar screen (12:59:13 UTC) showed the aircraft descending through 2,600ft, heading 330°, at a groundspeed of 175kt, at a distance of 2.5nm from the SAT NDB. The aircraft was to cross SAT NDB at an altitude of 1,700ft on the final approach.

By associating the aircraft position data generated by the radar at 12:59:43 with: -the vertical profile of the terrain on the final approach; - the MDA and SAT NDB crossing limits; - the projection of a final approach path towards runway 35 at an angle of 3.5°; and - the ceiling and visibility data reported in the METAR, it is possible to determine the scenario represented in Figure 171.

Figure 171 – Vertical Profile of: - the meteorological conditions; - ECHO 1 procedure restrictions, and - aircraft position detected by the radar at 12:59:13 UTC (not to scale).
Considering the ceiling and visibility, the crew would only have the runway in sight with the aircraft positioned to the left of the dotted line representing the 3,000-meter visibility in the graph, and below the blue line representing the ceiling.

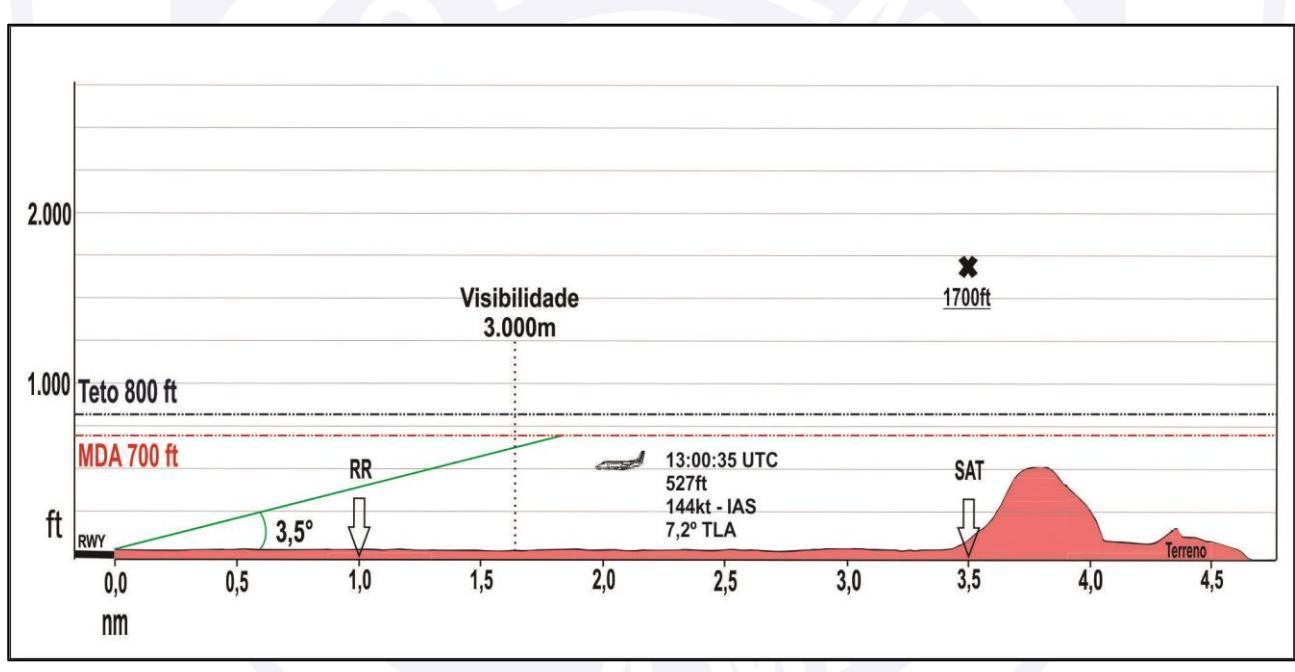
In the first hypothesis, the aircraft would be below the MDA, in a position that did not allow the crew to sight the landing runway while trying to reduce speed to  $V_{REF}$  +10kt.

In this condition, even though there was a possibility for the aircraft to adjust to the parameters for a stabilized final approach, it might be not aligned with the runway, unable to join the final approach axis, and exposed to a possible collision with obstacles (Figure 172).

Figure 172 – Hypothesis 1 for the aircraft position relative to the vertical profile, associated with the meteorological conditions and safety limits of the ECHO 1 procedure.

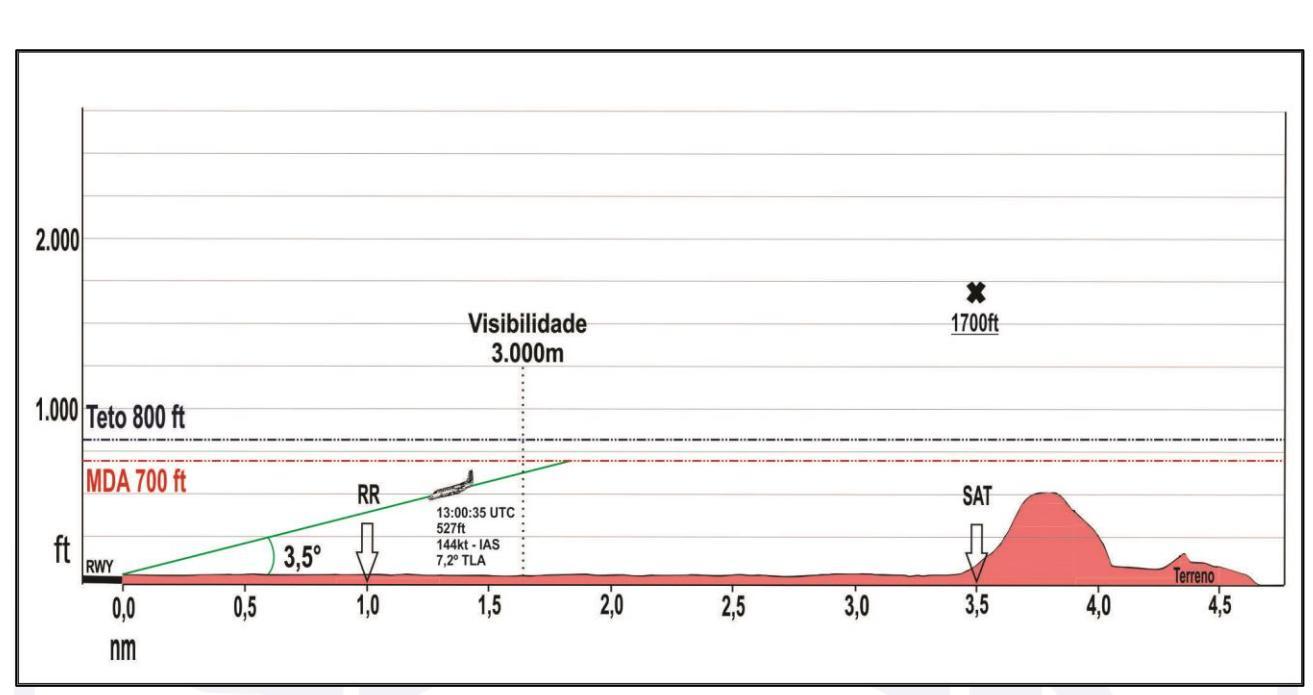
According to the second hypothesis, the aircraft would be on the approach ramp, but with a speed well above the  $V_{REF}$  + 10kt and, therefore, on anon-stabilized final approach (Figure 173).

Figure 173 – Hypothesis 2 for the aircraft position relative to the vertical profile, associated with the meteorological conditions and safety limits of the ECHO 1 procedure.

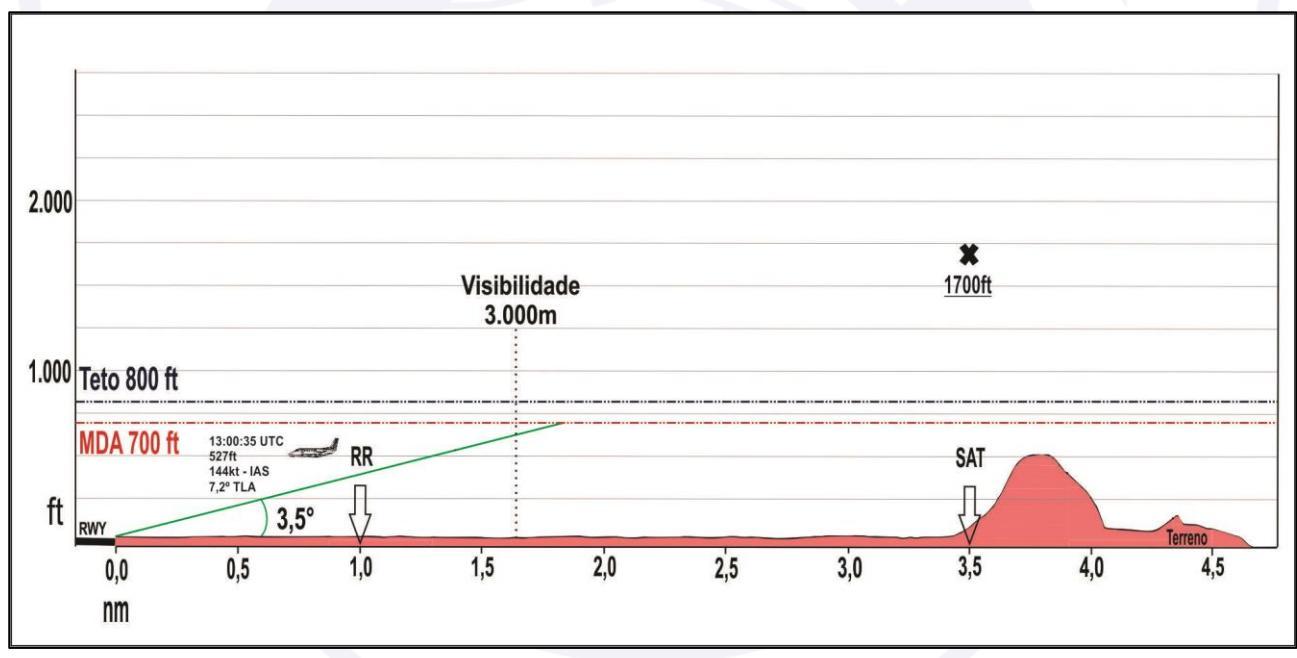
According to the third hypothesis, the aircraft would be above the approach ramp, at a speed well above the  $V_{REF}$  + 10kt, being, therefore, unable to make the landing (Figure 174).

Figure 174 – Hypothesis 3 for the aircraft position relative to the vertical profile, associated with the meteorological conditions and safety limits of the ECHO1 procedure.

Taking into account that the weather conditions were close to the IFR minima, the procedure should be performed in accordance with the official chart in the most accurate way possible. Considering the three hypotheses above, it is possible to see that, for the indicated airspeed and barometric altitude parameters associated with the meteorological conditions in the region, there was low probability that the aircraft would adjust to a stabilized approach.
