FINAL REPORT
IG-544/CENIPA/2015

OCCURRENCE:	SERIOUS INCIDENT
AIRCRAFT:	PR-OAF
MODEL:	F28MK0100
DATE:	21JAN2012

This is the Final Report of the 21 January 2012 serious incident involving the F28MK0100 aircraft, registration PR-OAF. The incident was classified as “in-flight fire”.

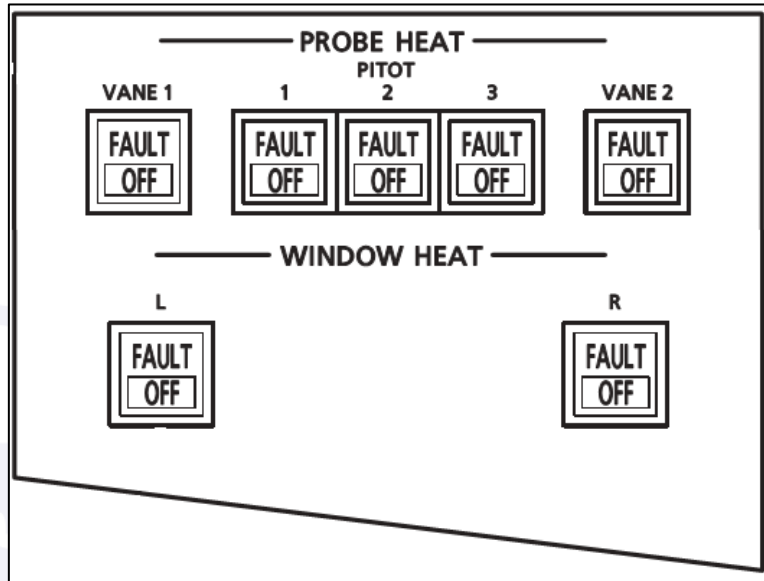
The Figure 1 shows the basic functioning of the Window Heat system, the controls of which are accessed on the right side of the upper panel. The functioning of the system, after the activation by means of a push-button, is fully automatic, without interference from the pilot after the conduction of the Clear to Start Checklist procedures.

Figure 1 - Window Heat Panel.
