**FINAL REPORT**  
**A - 173/CENIPA/2018**

| <b>AIRCRAFT:</b> | <b>PT-FPS</b> |
| <b>MODEL:</b> | <b>AW109SP</b> |
| <b>DATE:</b> | <b>24NOV2018</b> |

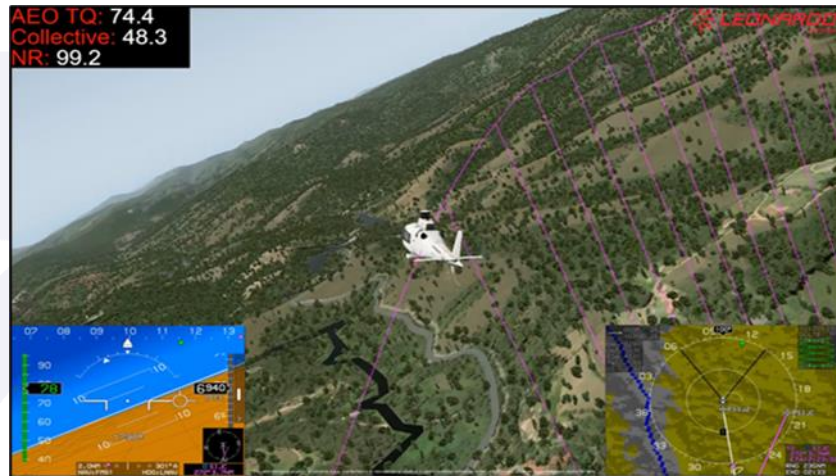
Therefore, based on the banks presented, it is likely that since the take-off from SJOQ to FSIJ2, the flight director was coupled to the aircraft's autopilot system. This scenario is reinforced by the overall evolution of speed, altitude and take-off data from SJOQ to FSIJ2, which showed little or no variation (Figure 23).

Figure 23 - Simulation of the turn to the right after passing the FSIJ2 point.

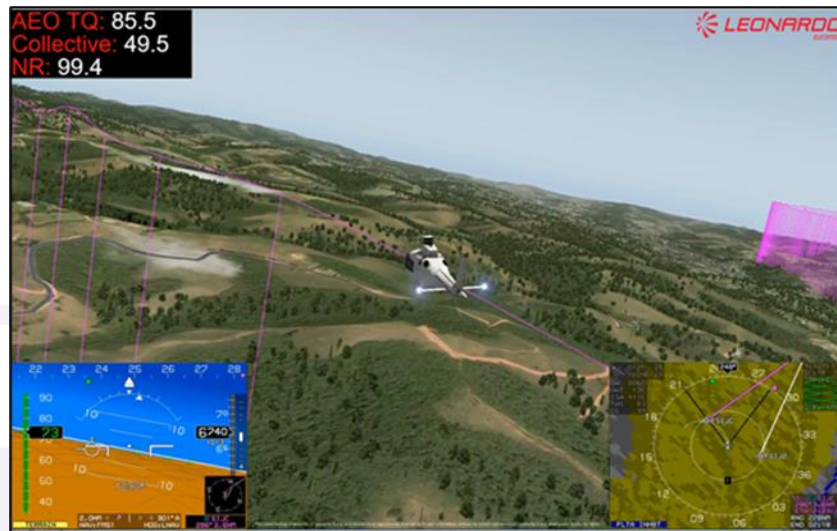
Figure 27 - Simulation of the deviation to the left, probably with manual heading variation.

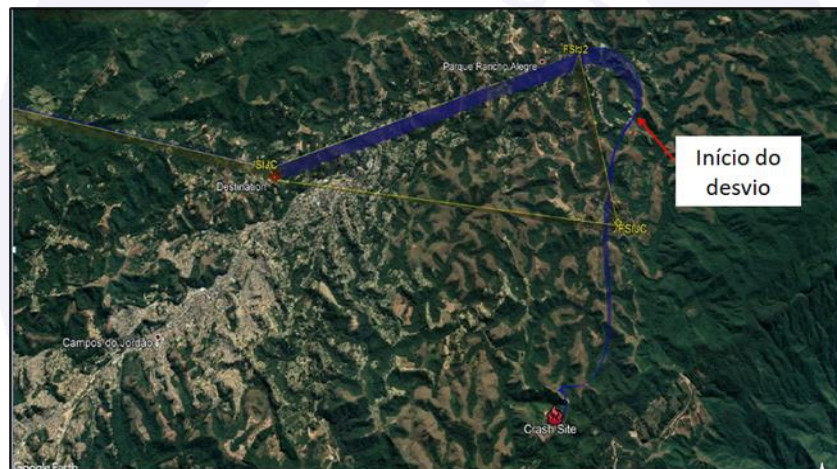
However, the aircraft continued south with an average heading of 205° to 210° and a descent rate of 600-700 ft/min.

Figure 28 - Simulation of the route with the beginning of the detour.

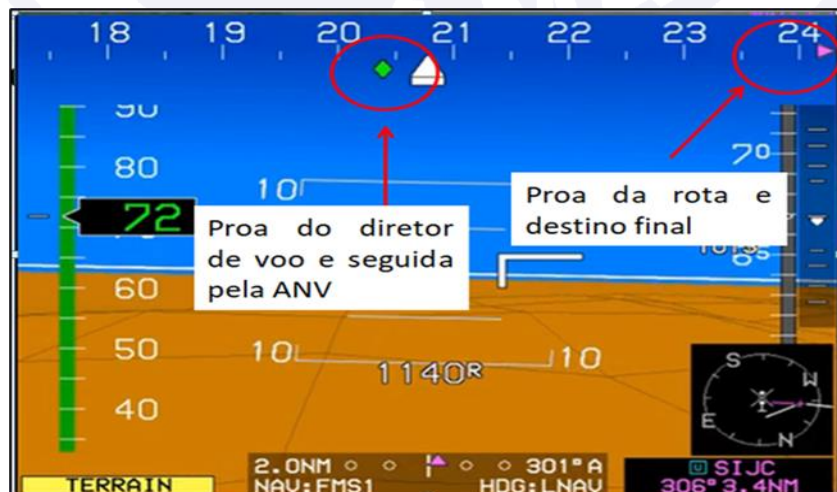
Figure 29 - Reconstruction of the ADI view.

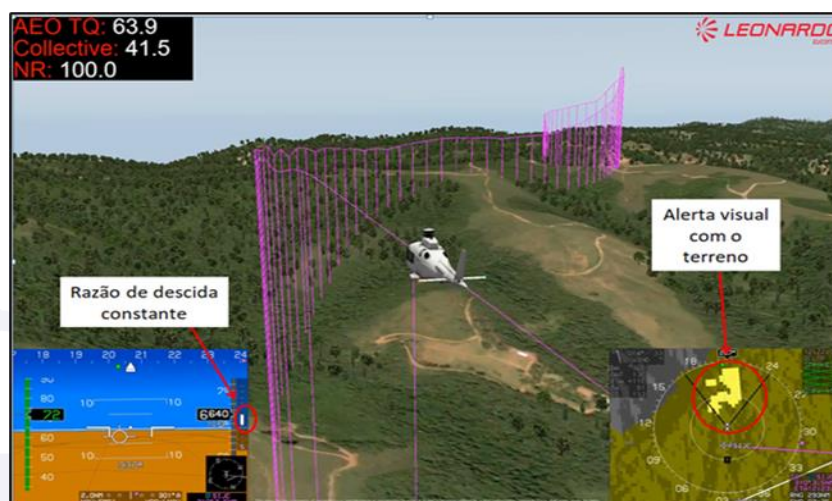
Shortly after flying over the FSIJC, from 12:22:02 (UTC) onwards, the aircraft maintained a constant rate of descent of 600-700 ft/min.

Figure 30 - Simulation of descent after FSIJC.

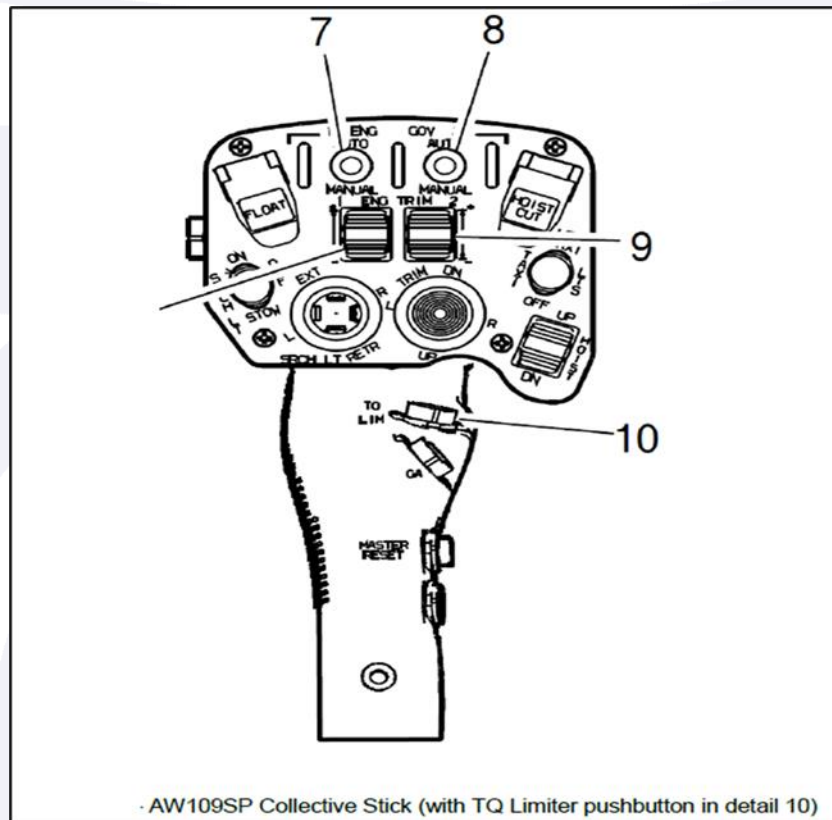
This was consistent with the activation of the Engine Torque Limiter, a function that affects the PW207C engine which equipped the aircraft.

Figure 33 - Collective Stick AW109SP (with TQ Limiter button in detail 10).  
Source: Adapted from Section 7 - System Description of the AW109SP RFM.

According to the analysis of the DCUs by the engine manufacturer, it was shown that this function was active at the time of impact.

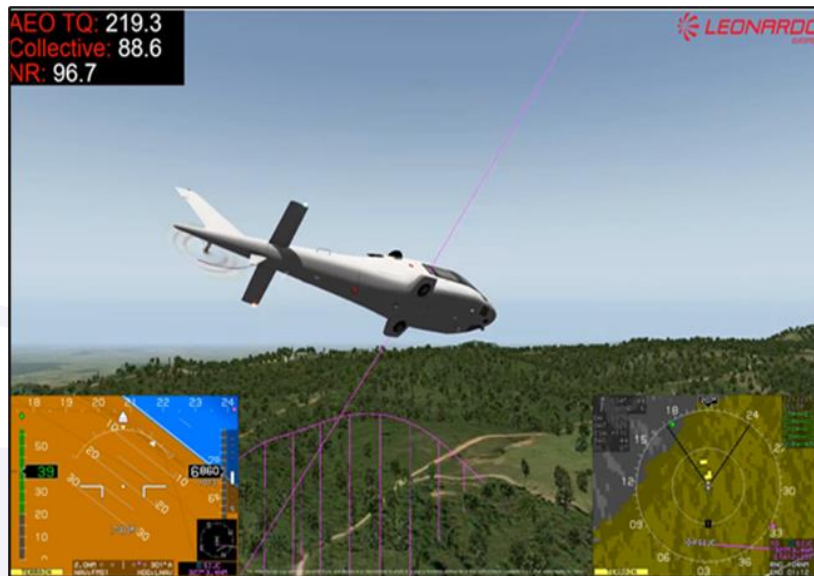
Figure 37 - Simulation of the beginning of loss of control.

After this period, the vertical velocity of the PT-FPS suddenly and constantly decreased to negative values, until the impact against the ground at 12:23:13 (UTC), with 167 kt of ground speed and 10,000 ft/min of descent rate.
